Higgins Lake Improvement Study and Management Plan Roscommon County, Michigan

Provided for: Higgins Lake Property Owners Association (HLPOA) Board

**Prepared by: Restorative Lake Sciences
Dr. Jennifer L. Jermalowicz-Jones, PhD
Water Resources Director
18406 West Spring Lake Road
Spring Lake, Michigan 49456
www.restorativelakesciences.com**

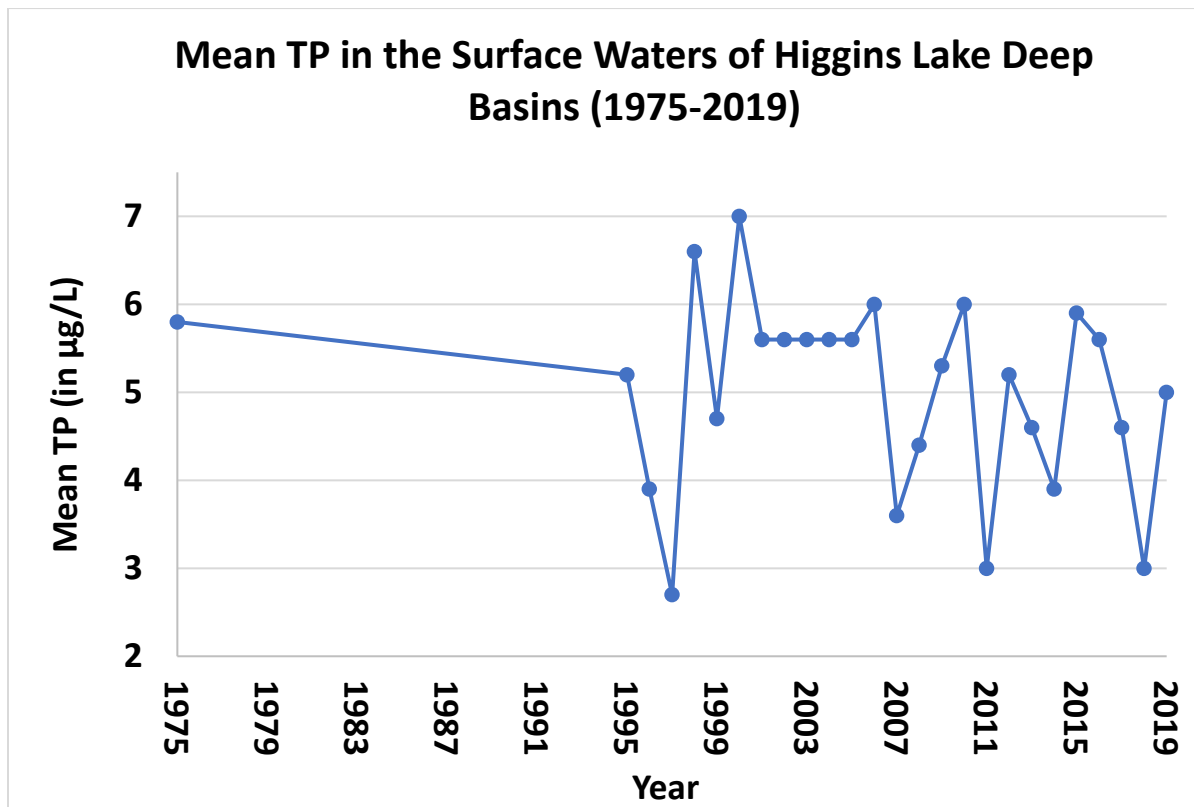
Figure 8. Trends in mean total phosphorus (in µg/L) with time in the surface waters of the Higgins Lake deep basins. Data from USEPA (1975), CLMP (2001-2018), and RLS (2019). Note: comparisons for the hypolimnion could not be made due to differences in sampling methodology.

Total phosphorus (TP) is a measure of the amount of phosphorus (P) present in the water column. Phosphorus is the primary nutrient necessary for abundant algae and aquatic plant growth. Lakes which contain greater than 0.020 mg/L (or 20 µg/L) of TP are defined as eutrophic or nutrient-enriched. TP concentrations are usually higher at increased depths due to the higher release rates of P from lake sediments under low oxygen (anoxic) conditions. Phosphorus may also be released from sediments as pH increases. Total phosphorus was measured in milligrams per liter (mg/L) with the use of Method EPA 200.7 (Rev. 4.4). The total phosphorus (TP) concentrations in the lake deep basins ranged from <0.010-0.043 mg/L during the August 22, 2019 sampling event. The highest concentration was measured near the middle of deep basin #4 and the reason for this elevated concentration is unknown. Previous studies (Minnerick, 2001) noted that phosphorus was elevated nearshore relative to the open waters which is indicative of septic system leachate entering the groundwater. An earlier USEPA study (1975) determined that the major contributing sources of phosphorus to Higgins lake in order of magnitude include direct precipitation, septic systems, minor tributaries, and Big Creek. Figure 8 demonstrates the trends in mean TP concentrations with time from the surface waters of Higgins Lake.

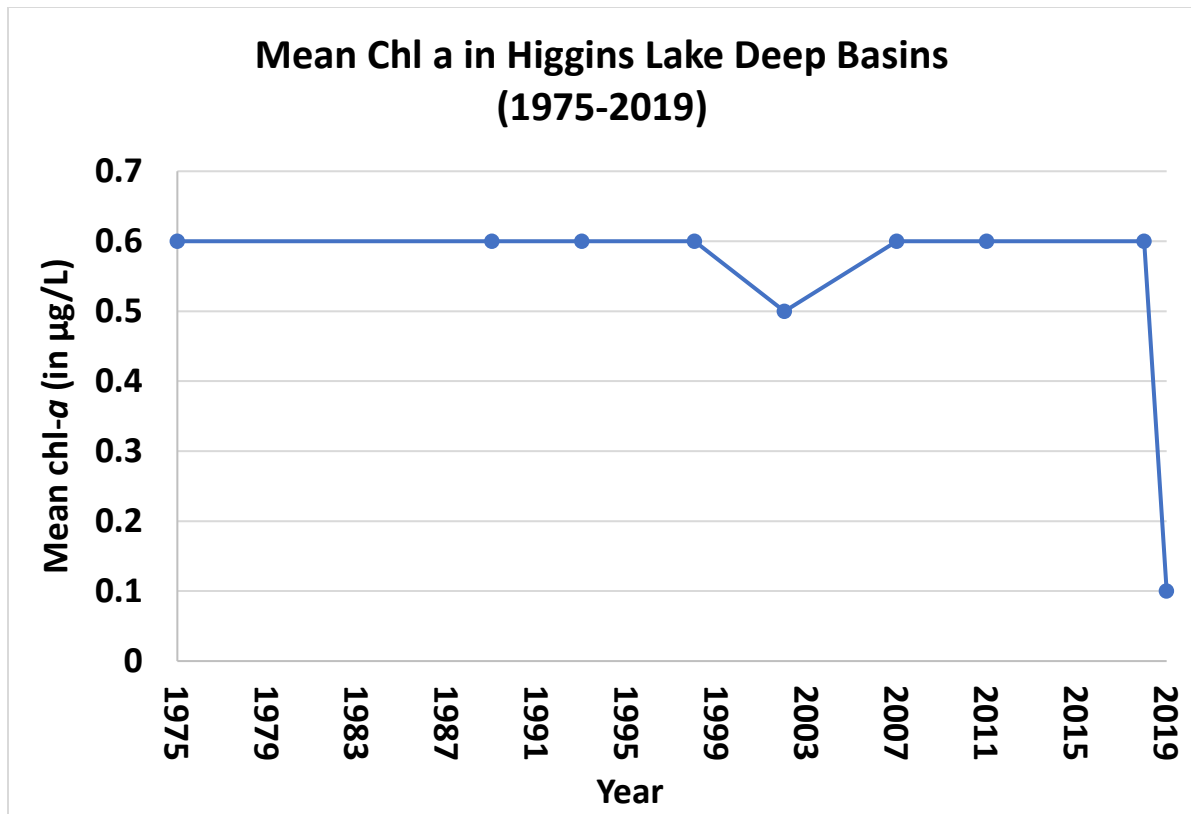
Figure 9. Trends in mean chlorophyll-*a* with time in Higgins Lake (1975-2019). Data from USEPA (1975), CLMP (2001-2018), and RLS (2019).

Chlorophyll-*a* is a measure of the amount of green plant pigment present in the water, often in the form of planktonic algae. High chlorophyll-*a* concentrations are indicative of nutrient-enriched lakes. Chlorophyll-*a* concentrations greater than $6 \mu\text{g/L}$ are found in eutrophic or nutrient-enriched aquatic systems, whereas chlorophyll-*a* concentrations less than $2.2 \mu\text{g/L}$ are found in nutrient-poor or oligotrophic lakes.

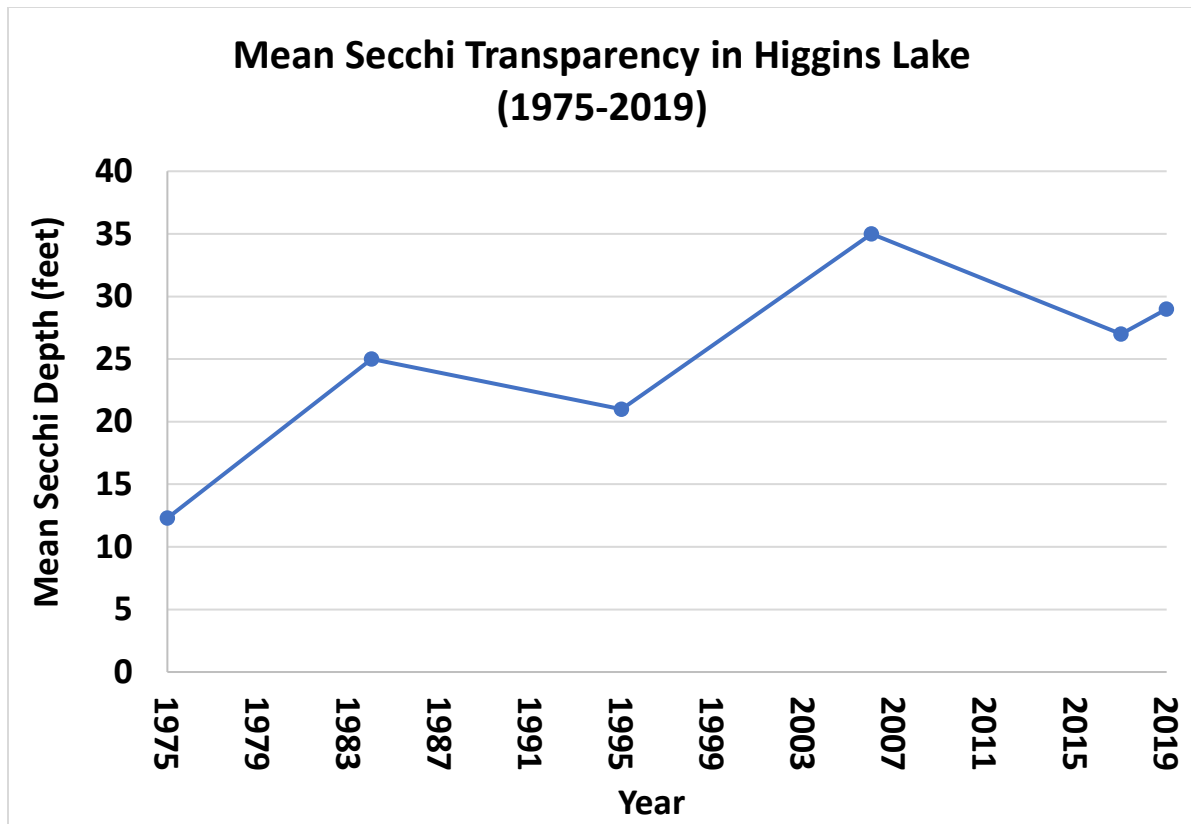
Figure 11. Trends in Secchi transparency with time in Higgins Lake (1975-2019). Data from USEPA (1975), CLMP (2001-2018), and RLS (2019).

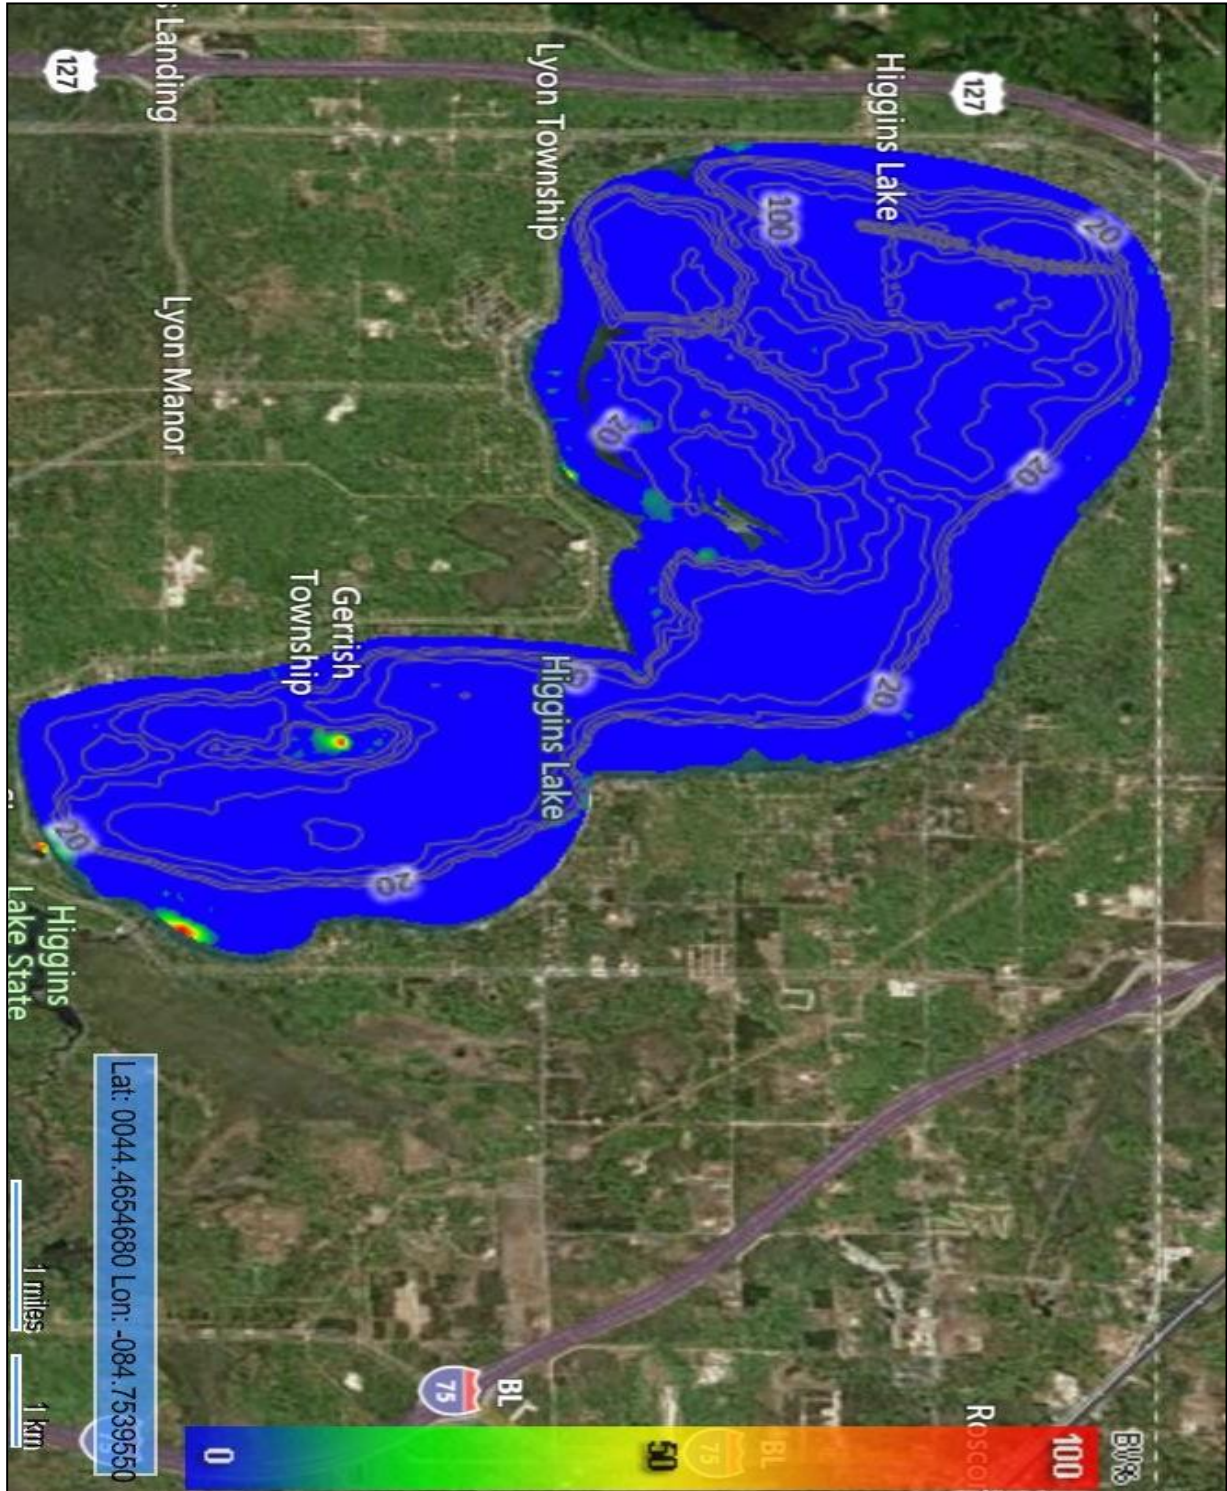
Figure 12. Aquatic plant biovolume of all aquatic plants in Higgins Lake, Roscommon County, Michigan (August 21-23, 2019). Note: Red color denotes high-growing aquatic plants, green color denoted low-growing aquatic plants, and blue color represents a lack of aquatic vegetation.

The GPS Point-Intercept/AVAS survey of Higgins Lake was conducted on August 21-23, 2019 and consisted of 2,564 sampling locations around the littoral zone which includes the area around the islands (Figure 13). Data were placed in a table showing the relative abundance of each aquatic plant species found and a resultant calculation showing the frequency of each plant.

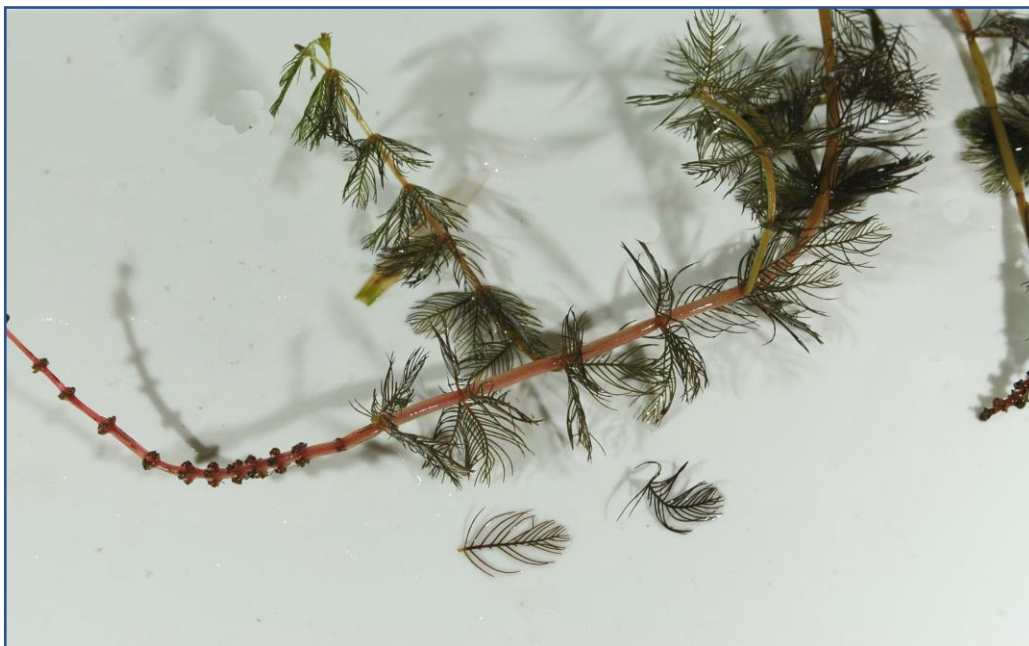
Figure 32. Hybrid Eurasian Watermilfoil plant with seed head and fragments.

In recent years, this species has hybridized with native milfoil species to form hybrid species. Eurasian Watermilfoil has since spread to thousands of inland lakes in various states through the use of boats and trailers, waterfowl, seed dispersal, and intentional introduction for fish habitat. Eurasian Watermilfoil is a major threat to the ecological balance of an aquatic ecosystem through causation of significant declines in favorable native vegetation within lakes (Madsen et al. 1991), in that it forms dense canopies (Figure 33) and may limit light from reaching native aquatic plant species (Newroth 1985; Aiken et al. 1979). Additionally, Eurasian Watermilfoil can alter the macroinvertebrate populations associated with particular native plants of certain structural architecture (Newroth 1985).

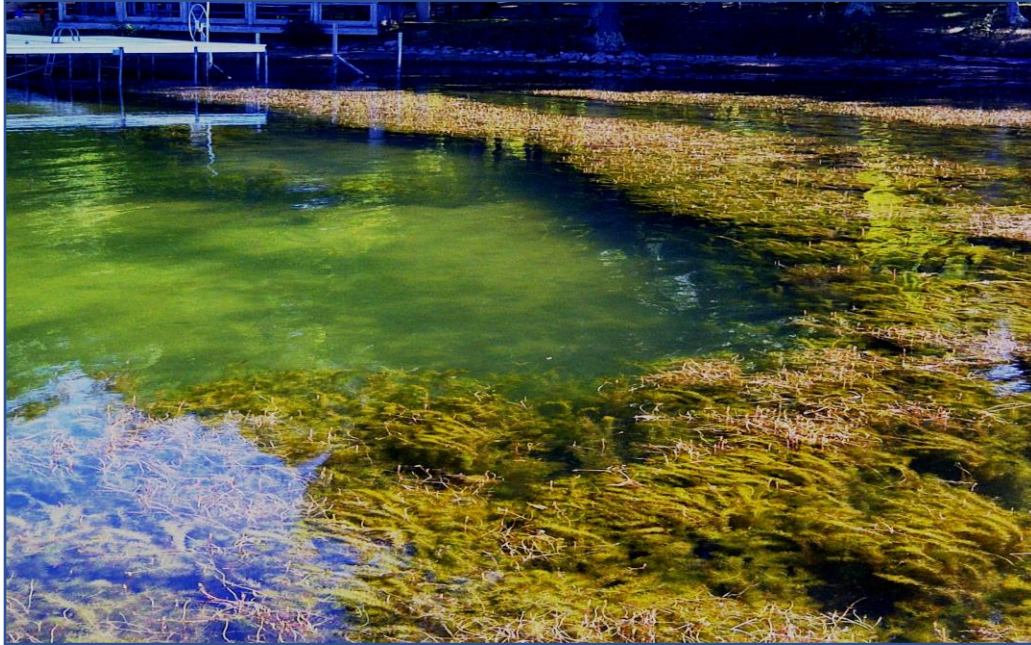
Figure 33. Eurasian Watermilfoil Canopy on an inland lake.

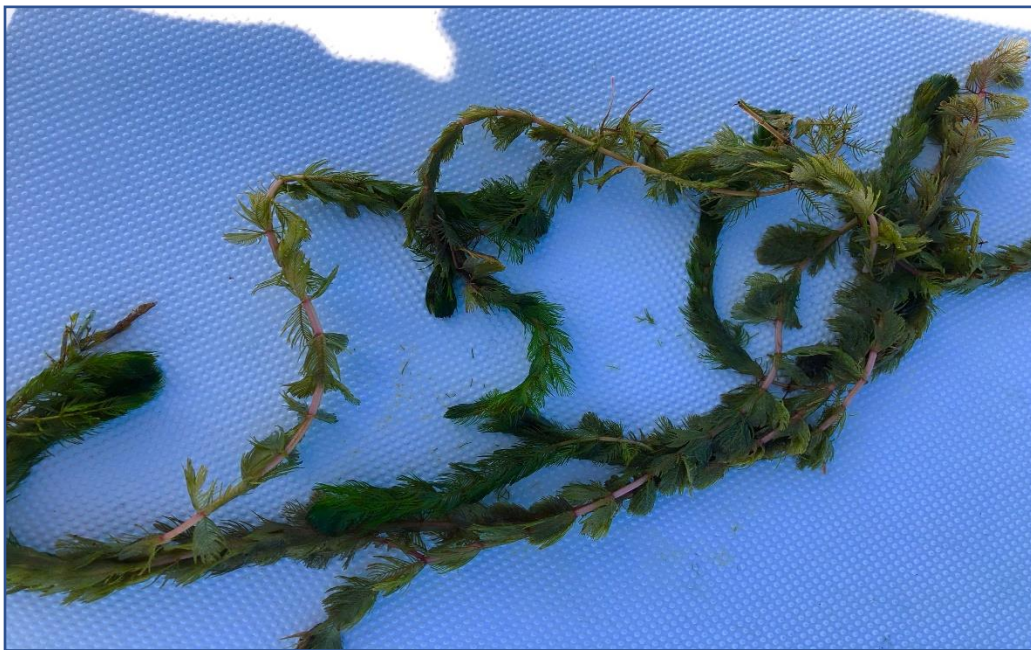
Figure 34. A Eurasian Watermilfoil stem from Higgins Lake.

Approximately 21.1 acres of Eurasian Watermilfoil was found in Higgins Lake during the August 21-23 survey and an intensive management program is proposed below. Eurasian Watermilfoil growth in Higgins Lake is capable of producing dense surface canopies in shallow areas; however, many plant beds were small and covered with marl precipitate (Figure 34) which can reduce the growth rate of the plant. The species of invasive aquatic plants present and relative abundance of each plant are recorded and then the amount of cover in the littoral zone is calculated. Exotic aquatic plant species that have been found in Higgins Lake are shown in Table 17 below and discussions of key invasives also follow below. Additionally, some milfoil was found to have Zebra Mussels attached to the stems which allows the plants to serve as another substrate for these invasive mussels (Figure 35). The distribution of milfoil throughout Higgins Lake is shown below in Figure 36.

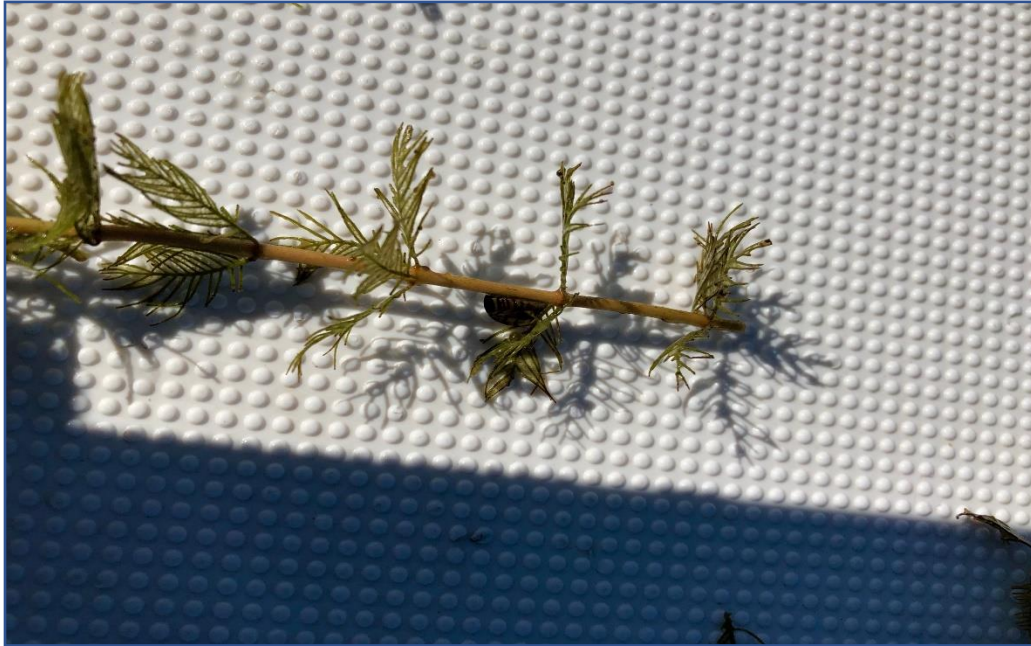
Figure 35. Eurasian Watermilfoil stem with attached Zebra Mussel in Higgins Lake.

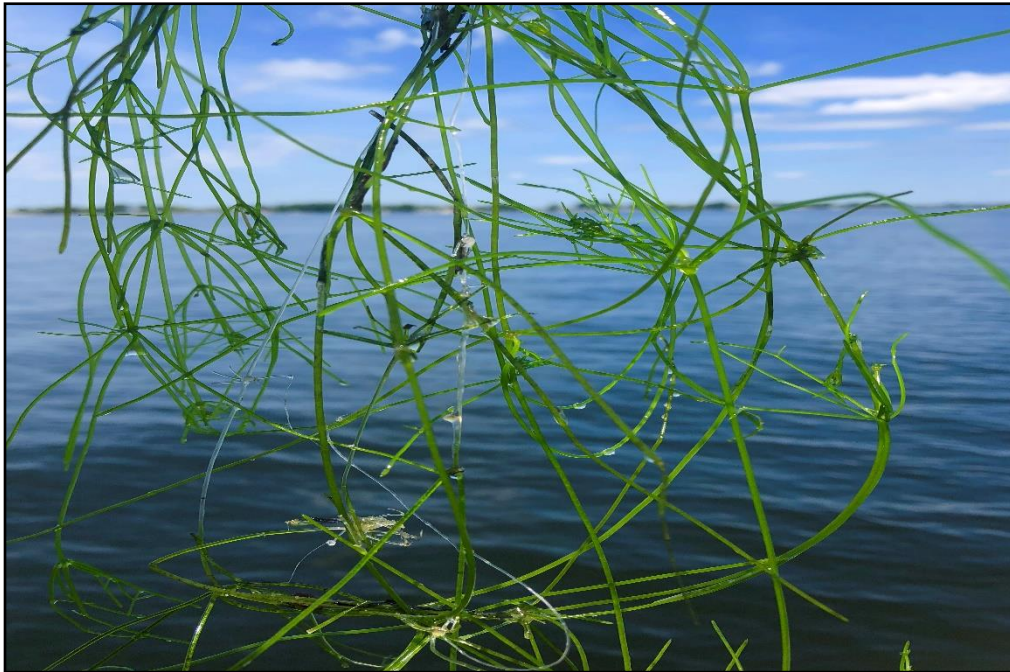
Figure 37. A fragment of Starry Stonewort.

Starry Stonewort (*Nitellopsis obtusa*; Figure 37) is an invasive macro alga that has invaded many inland lakes and was originally discovered in the St. Lawrence River. The “leaves” appear as long, smooth, angular branches of differing lengths. The alga has been observed in dense beds at depths beyond several meters in clear inland lakes and can grow to heights in excess of a few meters. It prefers clear alkaline waters and has been shown to cause significant declines in water quality and fishery spawning habitat. Individual fragments can be transported to the lake via waterfowl or boats. These conditions make Higgins Lake vulnerable to its growth. It is light-limited in the deeper waters, although some free-floating fragments were found in the deeper waters. The shallows are often high-energy which may also slow down its colonization. Approximately 2.5 acres were found throughout the lake (Figure 38) with 1.9 acres present in the South Park boat launch lagoon (Figure 39). This lagoon is currently acting as a breeding grounds for the Starry Stonewort which is allowing for spread into the open waters of the lake. A rigorous management program is proposed below for this plant and Eurasian Watermilfoil.

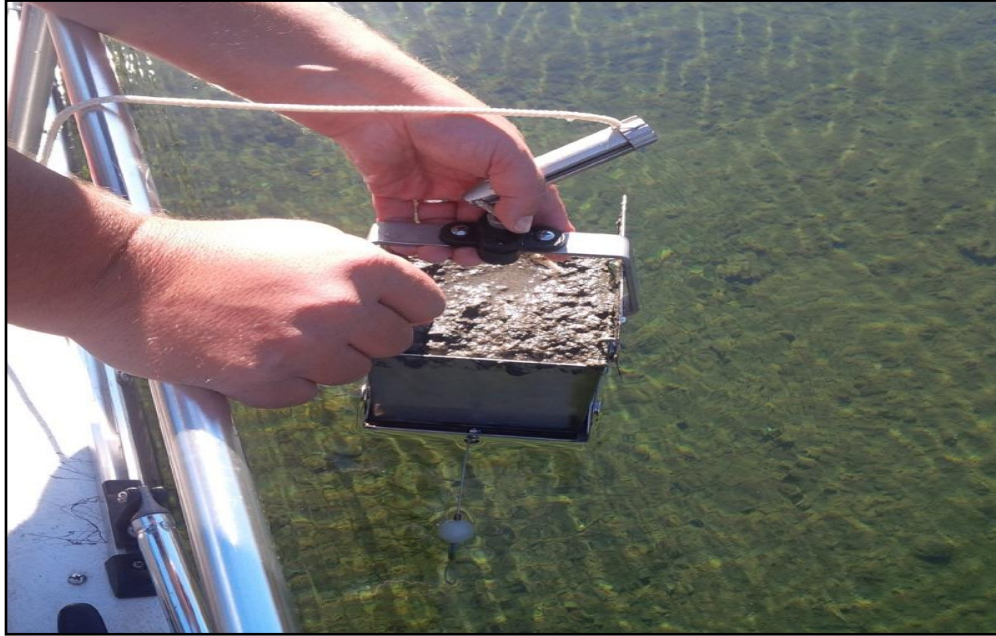
Figure 42. An Ekman hand dredge for sampling lake sediments.

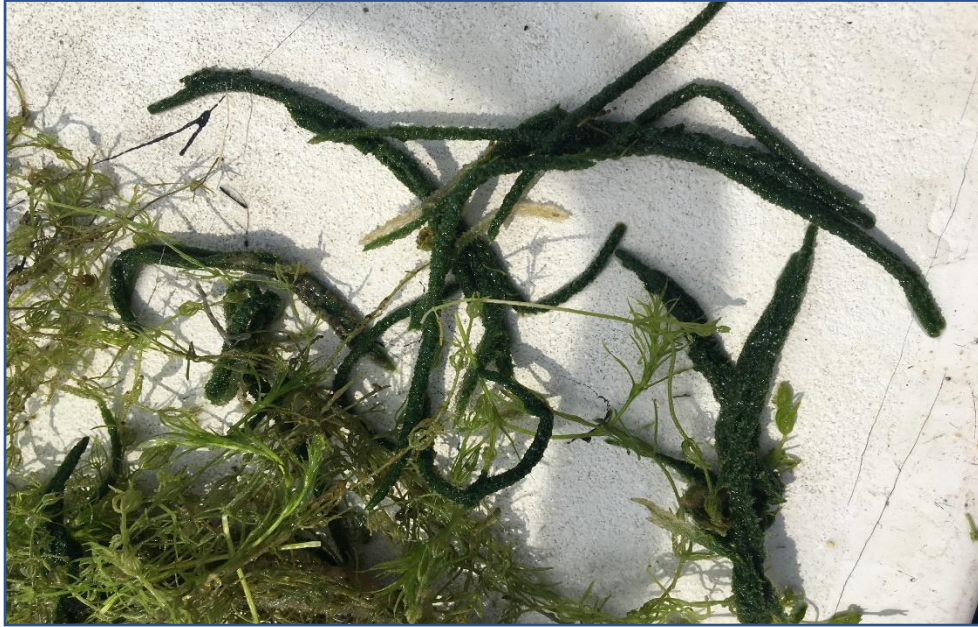
Figure 43. *Spongilla lacustris* from Higgins Lake.

S. lacustris is an indicator of clean and healthy waters and is found in North America, Europe, and Asia. The sponge grows until October in north temperate climates and overwinters as gemmules (Frost et *al.*, 1982). The sponge has the ability to reproduce both sexually and asexually. This sponge was found in many areas of Higgins Lake and was mostly associated with rocks and macrophytes in the lake (Figure 43).

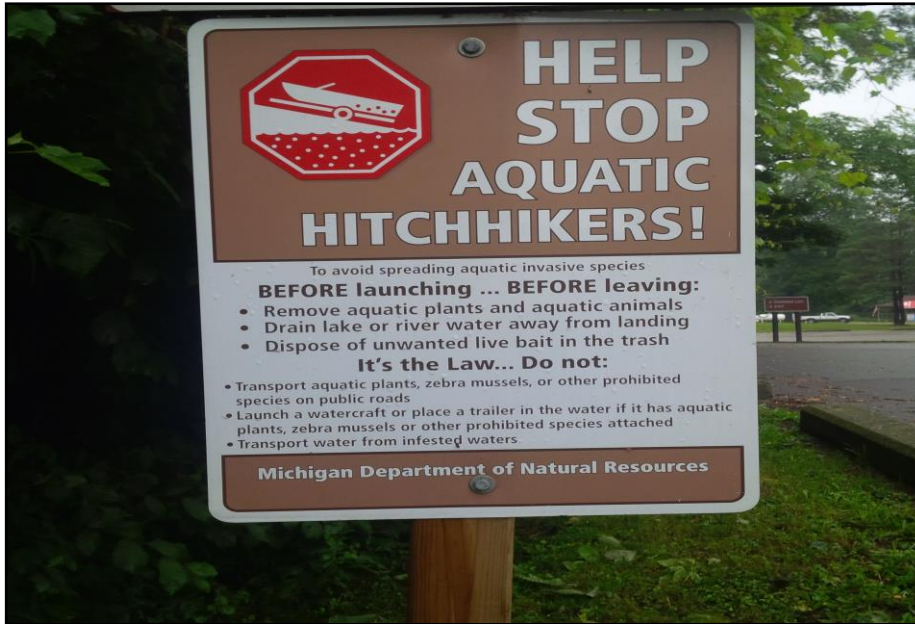
Figure 44. An aquatic invasive prevention sign for public access sites.

The first ingredient to successful prevention of unwanted transfers of exotic species to Higgins Lake is awareness and education (Figures 44 and 45). The exotic species of concern have been listed in this report. Other exotic species on the move could be introduced to the riparians around Higgins Lake through the use of a professionally developed educational newsletter or through public workshops on the health of the Higgins Lake ecosystem.

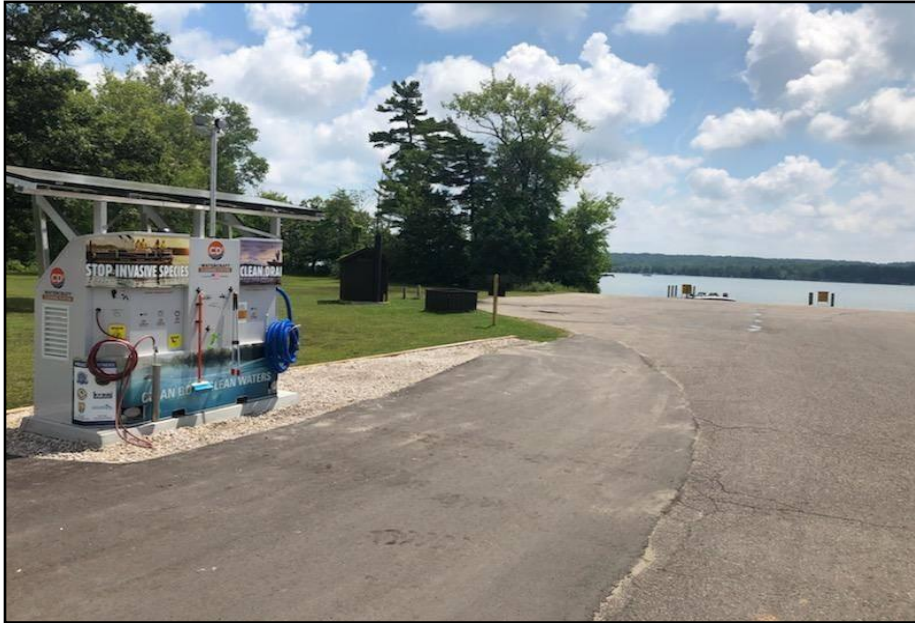
Figure 46. A public boat washing station at South Higgins Lake.

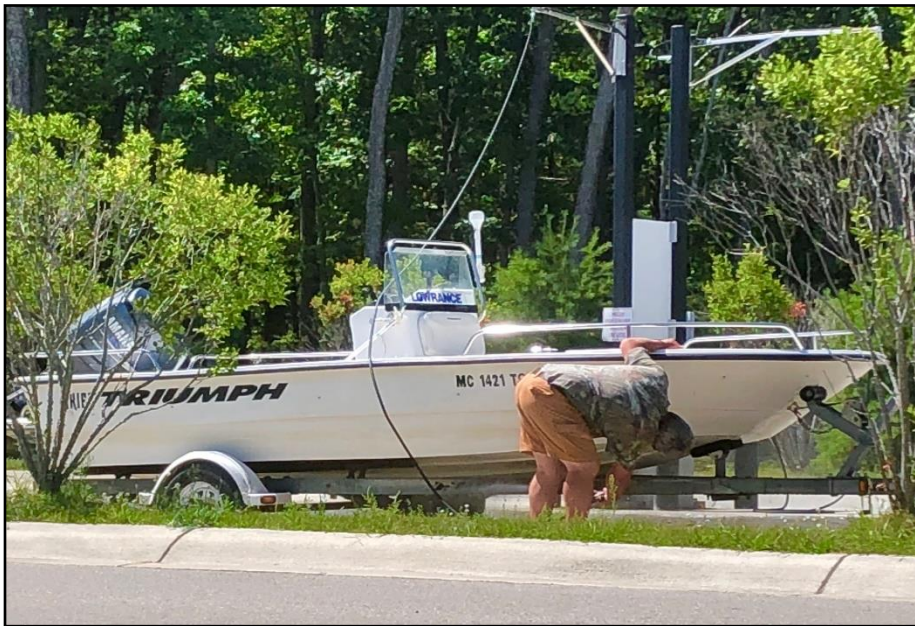
Figure 47. A responsible boat owner using the Higgins Lake boat washing station in 2019.

Recently, MSU partnered with EGLE to study the various forms of boat washing stations (including the innovative CD3 units) on the lake to analyze effectiveness of invasive removal, behavior patterns and preference for use, and short and long-term cost effectiveness of each system. This will assist in the placement of specific types of wash stations around other portals of entry around the lake. Figure 48 shows all of the probable areas of boat launch access around Higgins Lake. Boat washing stations and invasive species prevention signs are recommended at all of these sites where practical.

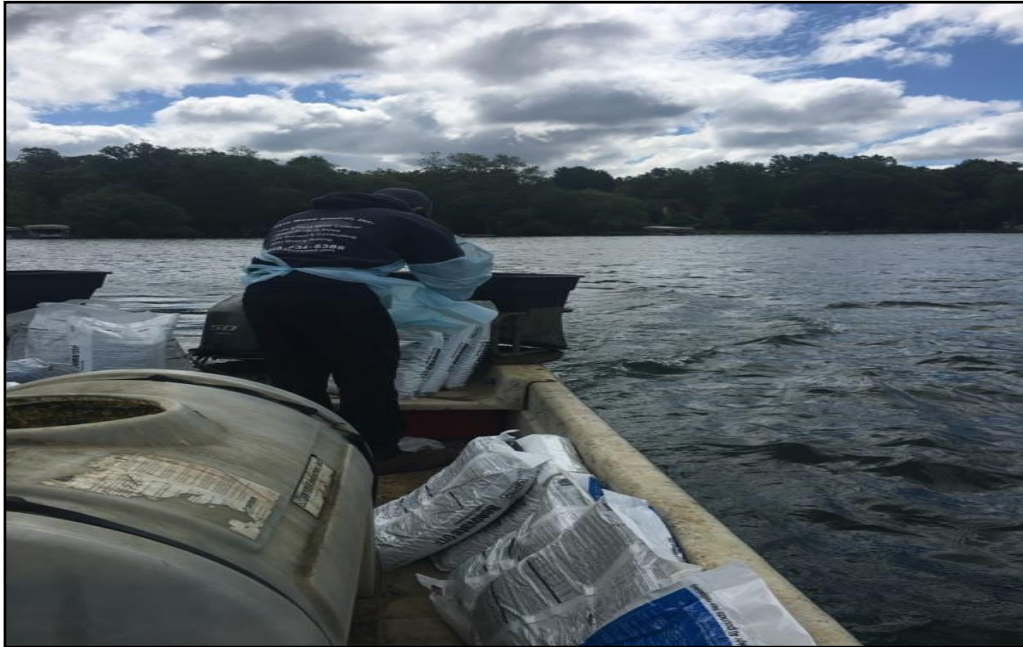
Figure 52. A boat used to apply aquatic herbicides in inland lakes.

Systemic herbicides such as 2, 4-D and triclopyr are the two primary systemic herbicides used to treat milfoil that occurs in a scattered distribution. Fluridone (trade name, SONAR®) is a systemic whole-lake herbicide treatment that is applied to the entire lake volume in the spring and is used for extensive infestations. The objective of a fluridone treatment is to selectively control the growth of milfoil in order to allow other native aquatic plants to germinate and create a more diverse aquatic plant community. Due to the low scattered abundance of milfoil in Higgins Lake (given its size), the use of fluridone is not recommended. RLS recommends that no aquatic herbicides be used in Higgins Lake unless the distribution of invasives exceeds the capacity for use of a DASH boat.

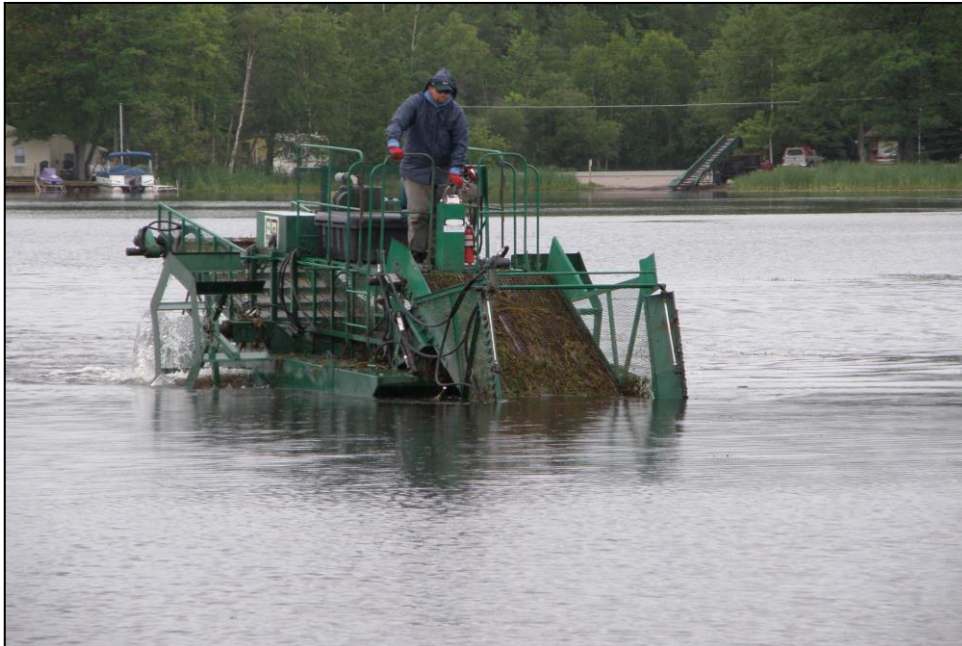
Figure 53. A mechanical harvester used to remove aquatic plants.

Mechanical harvesting is usually not recommended for the removal of Eurasian Watermilfoil since the plant may fragment when cut and re-grow on the lake bottom. Additionally, it is often not practical for very large lakes, given the long transfer times to offload harvested vegetation. Due to the lack of overall native aquatic vegetation and distribution of invasives in open water areas, mechanical harvesting is not recommended for Higgins Lake.

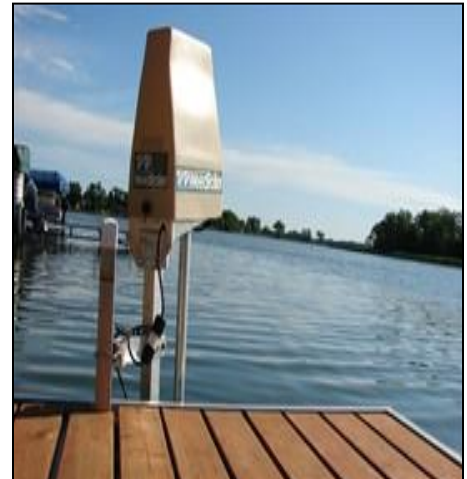
Figure 55. A Weed Roller.

Both methods are useful in recreational lakes such as Higgins Lake and work best in beach areas and near docks to reduce nuisance aquatic vegetation growth if it becomes prevalent in future years. Fortunately, the Higgins Lake bottom is not highly colonized with aquatic vegetation and these methods are not needed in most areas.

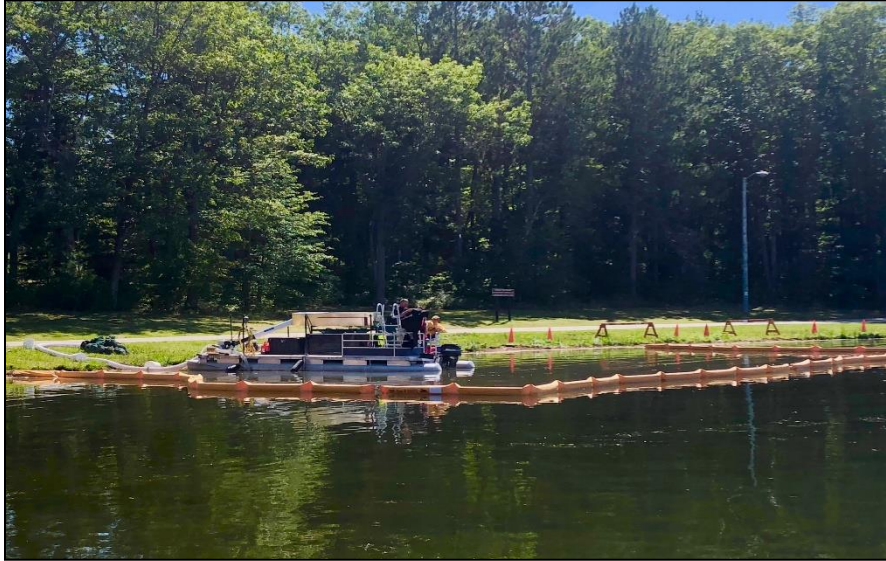
Figure 56. A DASH boat used in the South State Park Lagoon for aquatic plant removal.

Because this activity may cause re-suspension of sediments (Nayar et al., 2007), increased turbidity and reduced clarity of the water can occur. Permitting requirements include the use of a turbidity curtain that reduce the transport of solids to locations outside of treatment areas and also help define areas where intensive aquatic vegetation removal efforts are being implemented. This method would be feasible given the sparse distribution of invasive Eurasian Watermilfoil and Starry Stonewort scattered throughout Higgins Lake. It would be a non-chemical approach that would include removal of the roots for long-term, sustainable, control of invasive plants. Figures 57 and 58 below show the conditions of the invasive aquatic vegetation growth in the South State Park Lagoon before and after DASH and the parallel use of systemic herbicides in 2019, respectively.

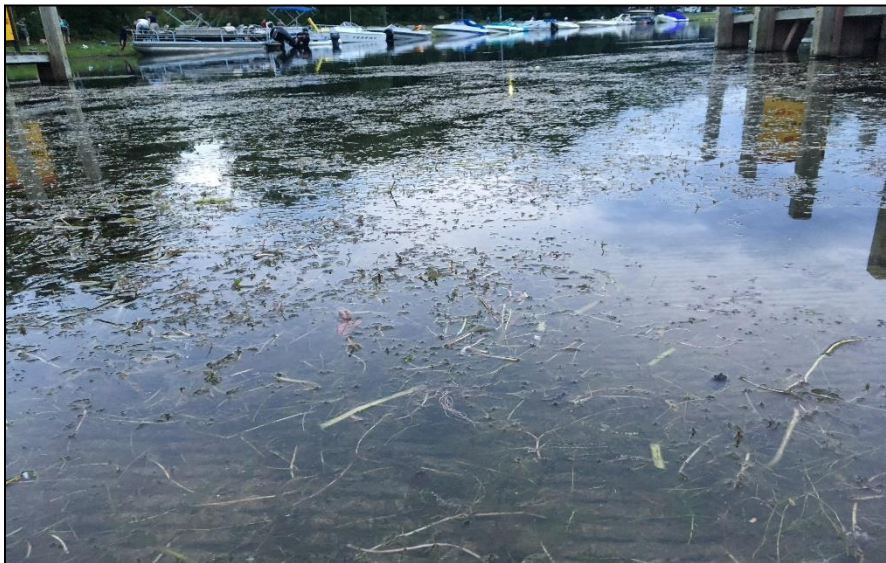
Figure 57. Nuisance aquatic vegetation in the South State Park Lagoon prior to management in 2019.

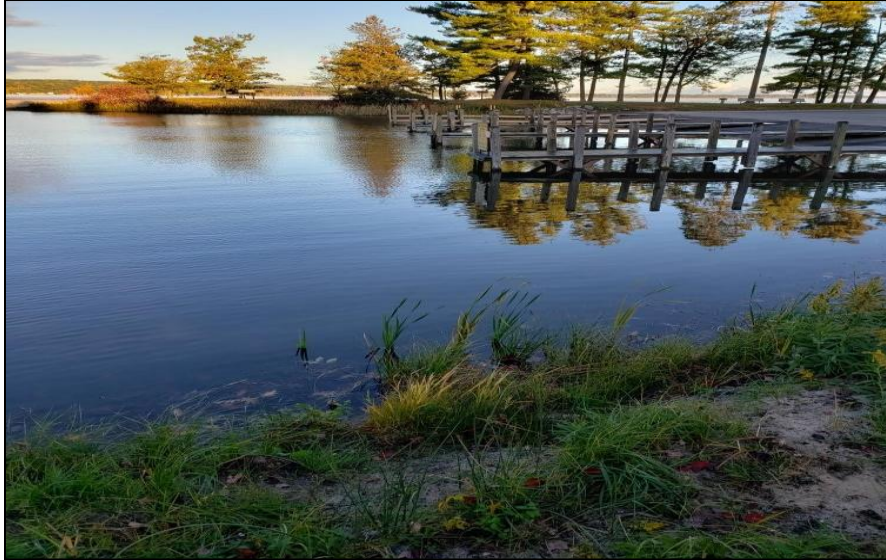
Figure 58. The South State Park Lagoon after DASH improvements in 2019.

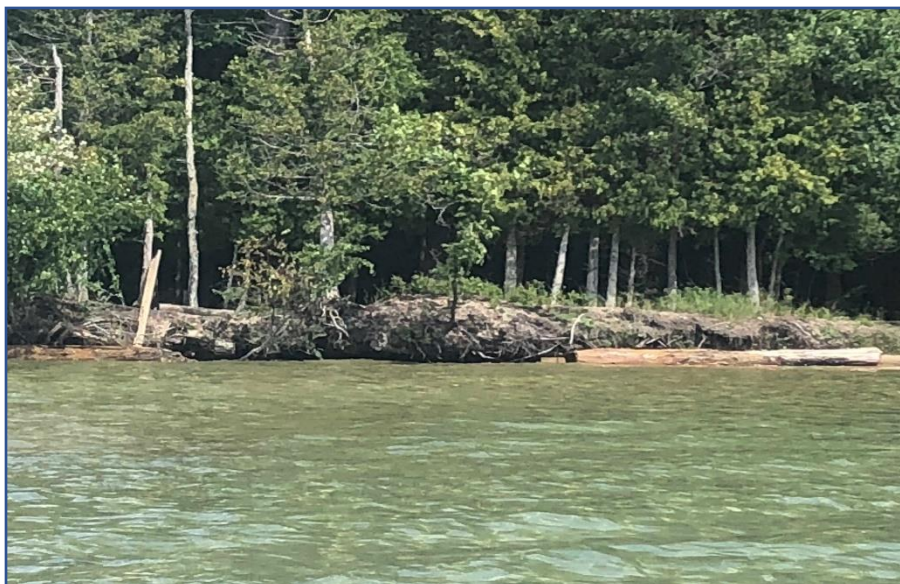
Figure 60. Shoreline erosion on Higgin Lake with bank undercutting (August 21-23, 2019).

Figures 60-62 demonstrate areas around the lake with different types of erosion including hill erosion, bank erosion, bank undercutting, and low stabilization. A specific whole-lake shoreline inventory of all erosion areas is recommended in the management recommendations table in Section 6.0.

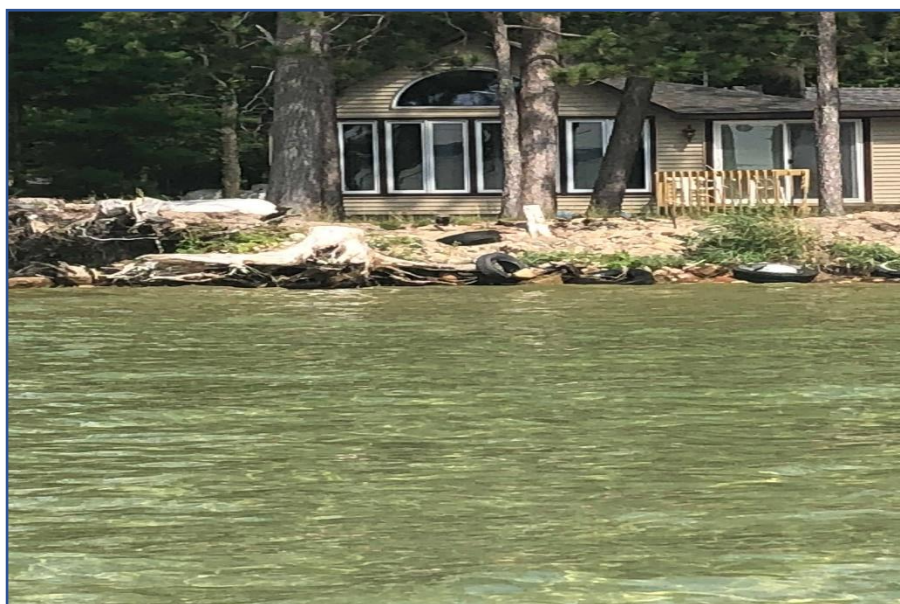
Figure 61. Shoreline erosion around Higgins Lake (August 21-23, 2019).

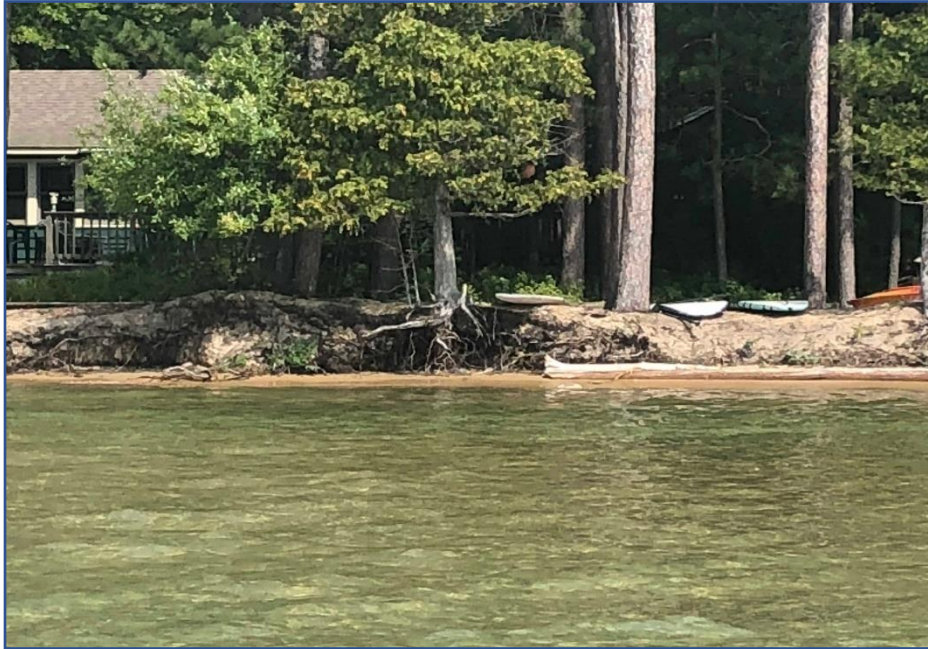
Figure 62. Higgins Lake shoreline erosion exposing tree roots (August 21-23, 2019).

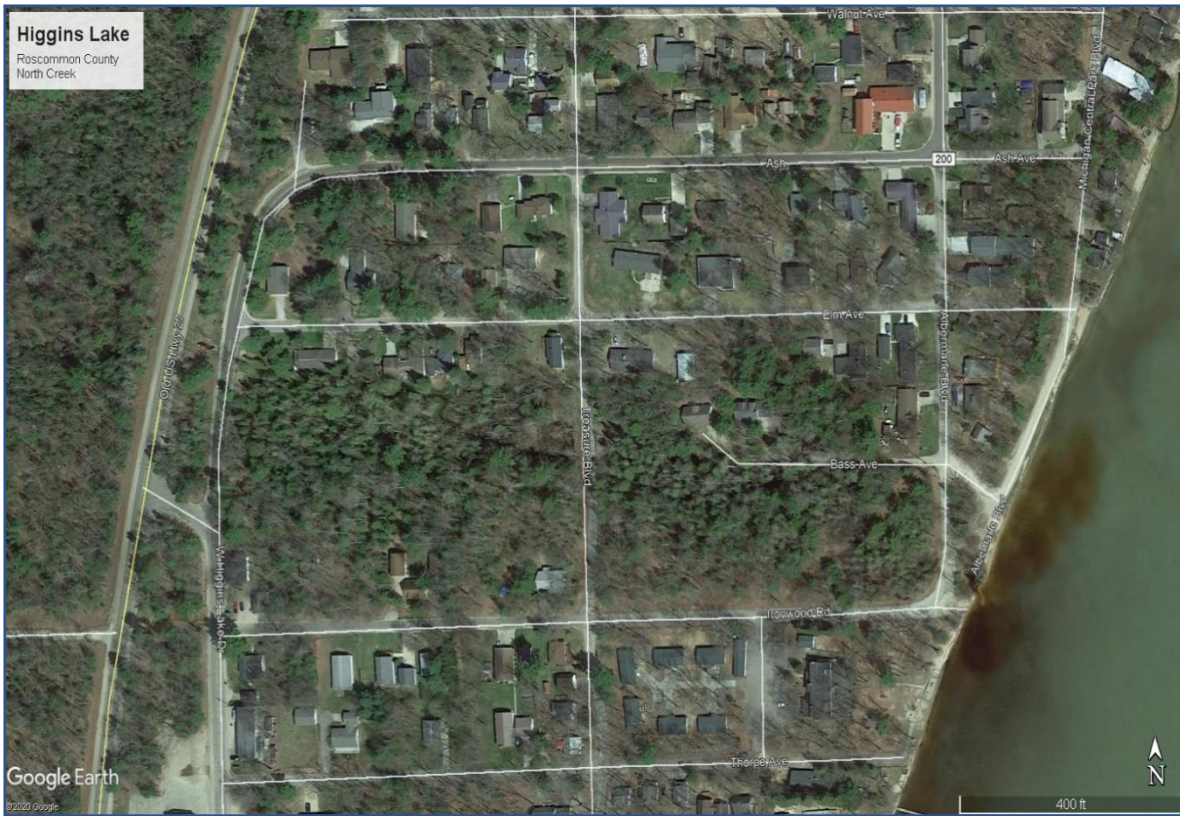
Figure 64. The North Creek on Higgins Lake measured on October 16, 2019. Note the high amount of tannins leaching into the lake.

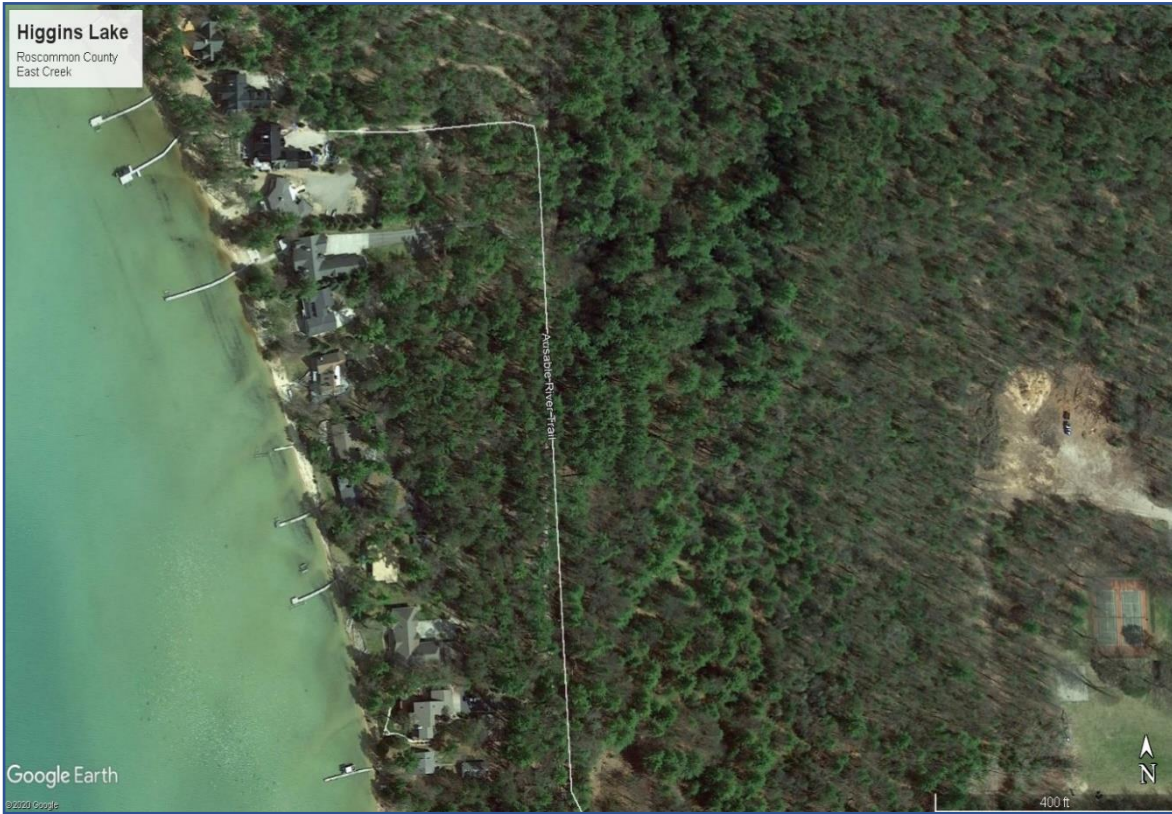
Figure 65. The East Creek on Higgins Lake measured on October 16, 2019.

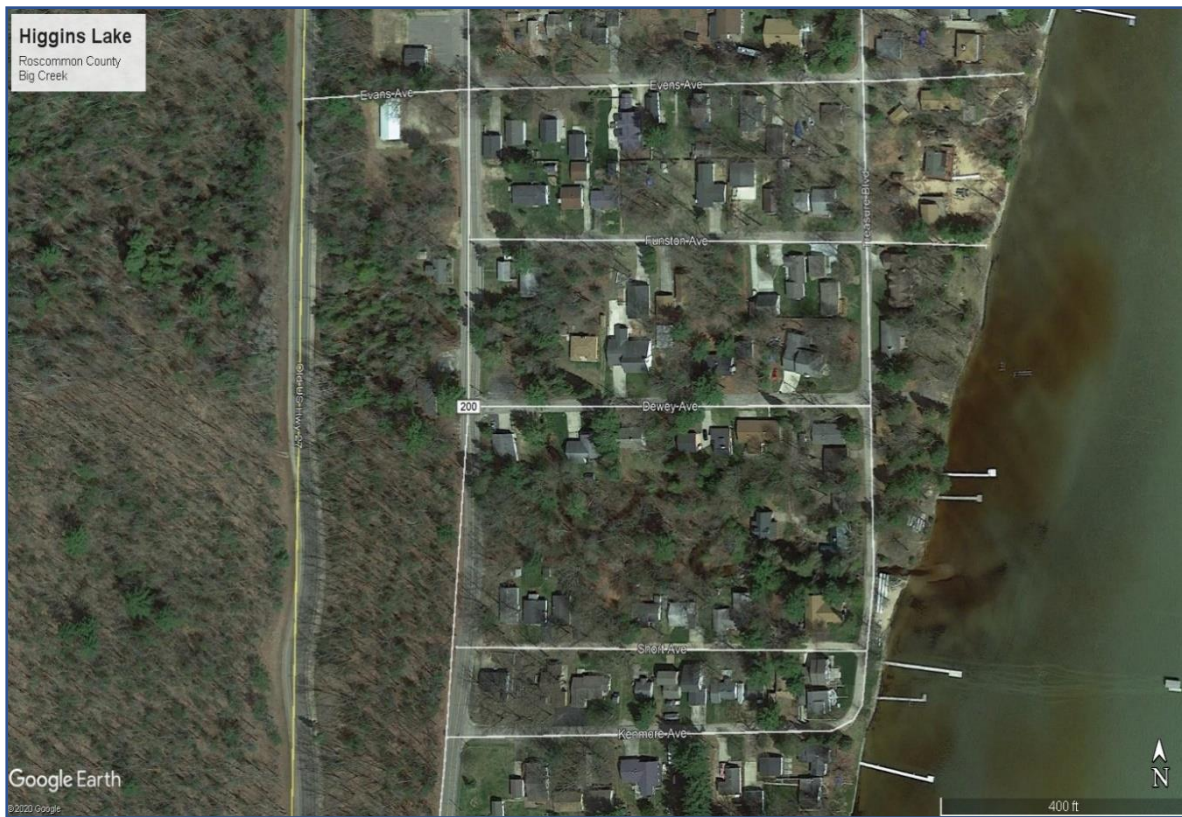
Figure 66. The Big Creek on Higgins Lake measured on October 16, 2019. Note the high amount of tannins leaching into the lake.
