MAINTAINING THE HIGH WATER QUALITY

HIGGINS LAKE

This study was made for an inventory of present land use in the Higgins Lake Drainage Basin and what affect this land use is having on the water quality.

The author walked the entire distance around Higgins Lake in April 1969 taking notes of man made and natural drains into the lake and other possible sources of pollutants caused by present land use.

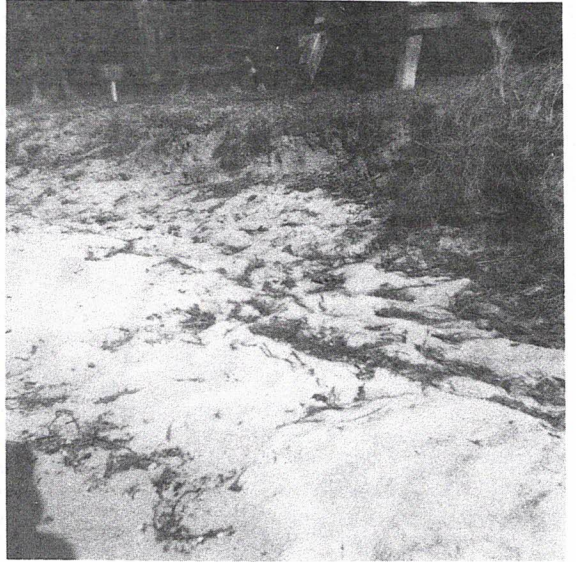
Beach erosion caused by wave action and use by people.

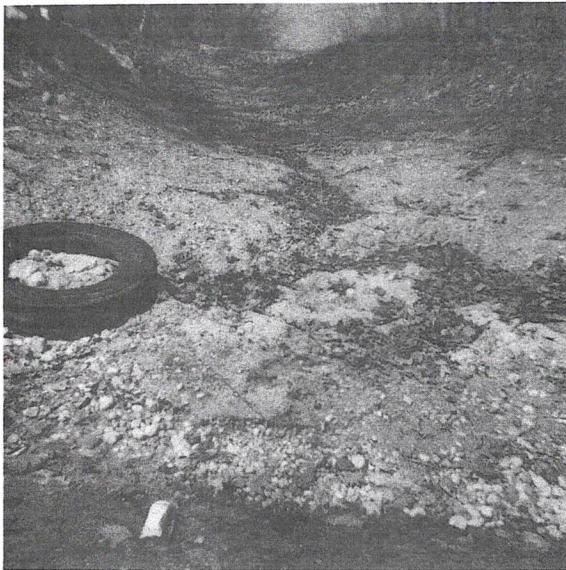
Sediments enter the lake at the end of Hislip Avenue.

Road-end erosion is an important source of soil sediments. The author counted 80 roads which either ended at the lake or at a boulevard. Where the road ended at a boulevard, many times the property owner dug an access to the lake, thus for all erosion purposes the road ended at the lake. Most of the roads have quite steep slopes, so are subject to erosion.

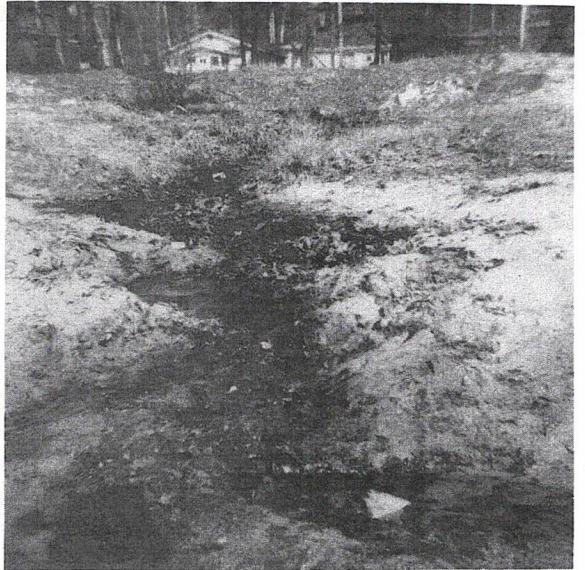
Organic sediments enter the lake from this drain on American Legion property.

Drains are necessary because of the dwellings along the lake. The drains would carry much less pollutants if they were properly designed to eliminate organic and soil sediments from entering the lake. Properly designed drains are needed to prevent flooding of septic tanks and disposal fields.

Three of the nineteen drains drain the American Legion grounds. They go through organic soil and carry organic sediments into the lake.

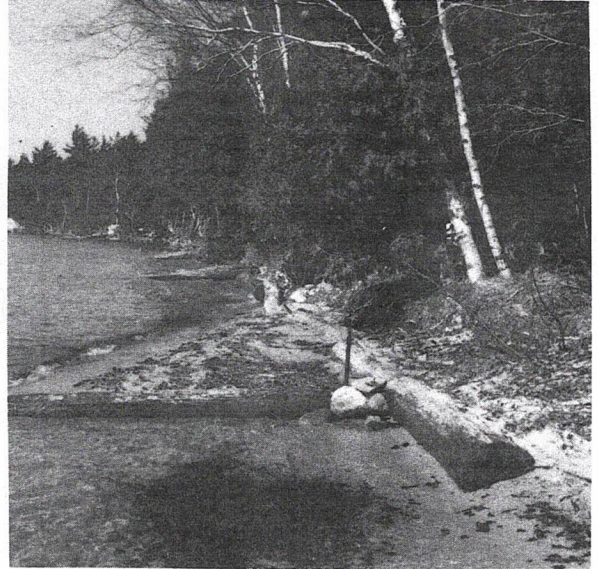
Log Jetties, perpendicular to the shore, protects the beach from long shore currents. Log revetment, parallel to the shore protect shore line.
