Higgins Lake 2022 Limnological Evaluation & Revised Lake Management Plan Roscommon County, Michigan

Provided for: Higgins Lake Property Owners Association (HLPOA) Board

**Prepared by: Restorative Lake Sciences
Dr. Jennifer L. Jermalowicz-Jones, PhD, CLP
Water Resources Director
18406 West Spring Lake Road
Spring Lake, Michigan 49456
www.restorativelakesciences.com**

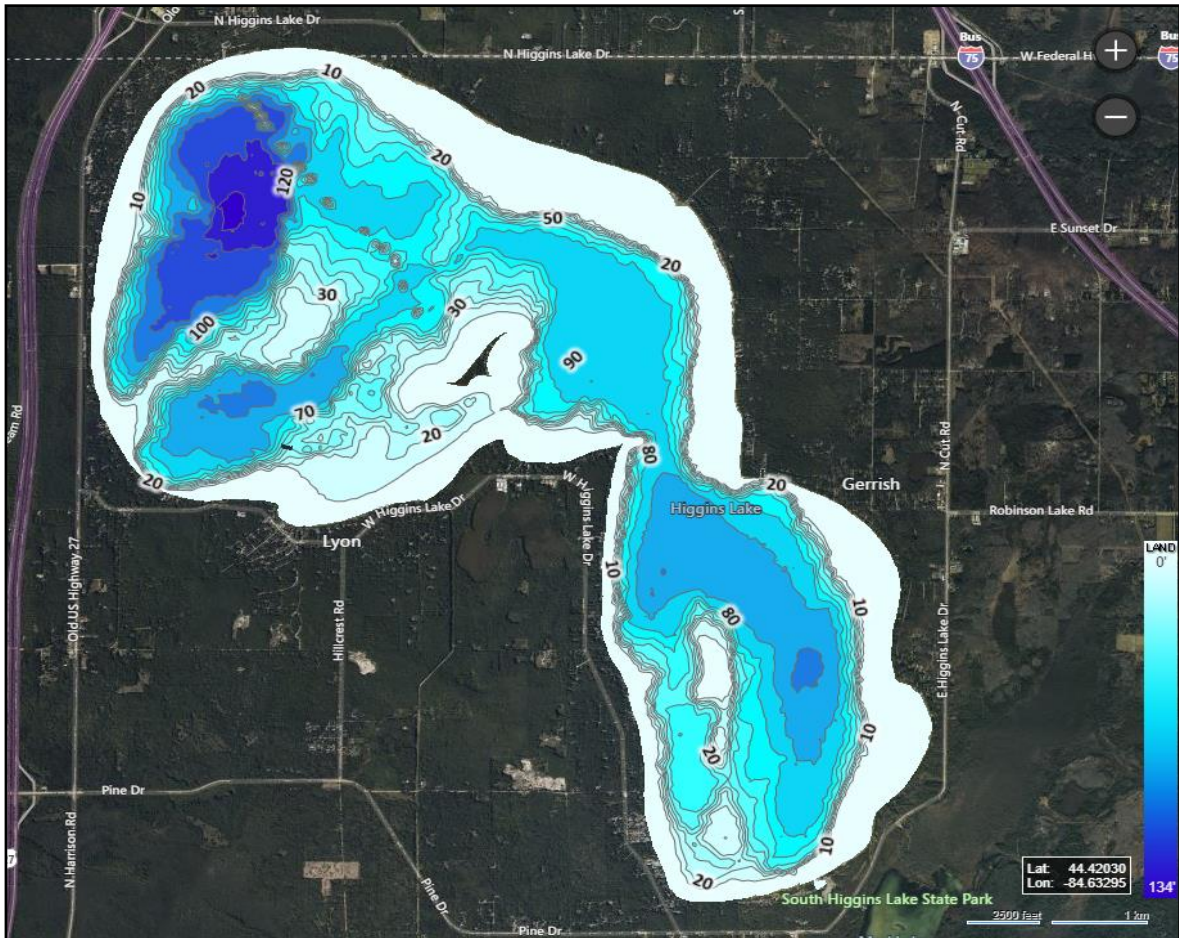
Figure 2. Higgins Lake 2022 Depth Contour Map, Roscommon County, Michigan.

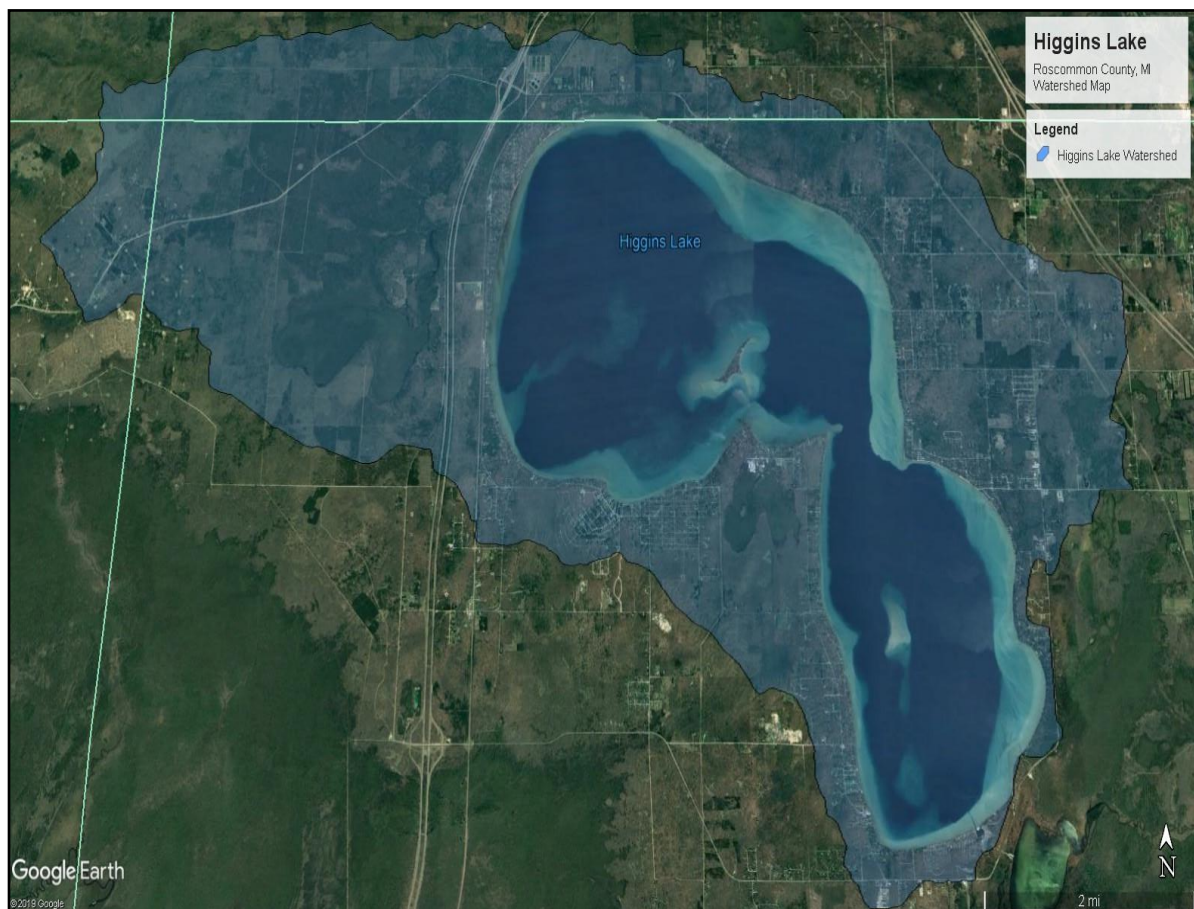
The immediate watershed of Higgins Lake consists of the area around the lake that directly drains to the lake and measures approximately 28,783 acres in size (Figure 4; RLS, 2019). The immediate watershed is about 3 times the size of the lake, which is considered a small immediate watershed. The lakefront itself has a diverse application of land uses such as beachfront for swimming, wetlands, and forested lands. Thus, management options should also consider all of these land uses and preserve their unique functions. Erosion and drain influxes of soils and nutrients are the second largest threat to the water quality of Higgins Lake next to septic systems. Some of the areas around the lake are also of high slope or unstable shorelines and are prone to erosion. Best Management Practices (BMP's) for water quality protection are offered in the watershed improvement section of this report.

Figure 4. Immediate Watershed draining into Higgins Lake, Roscommon County, Michigan (Restorative Lake Sciences, 2019).

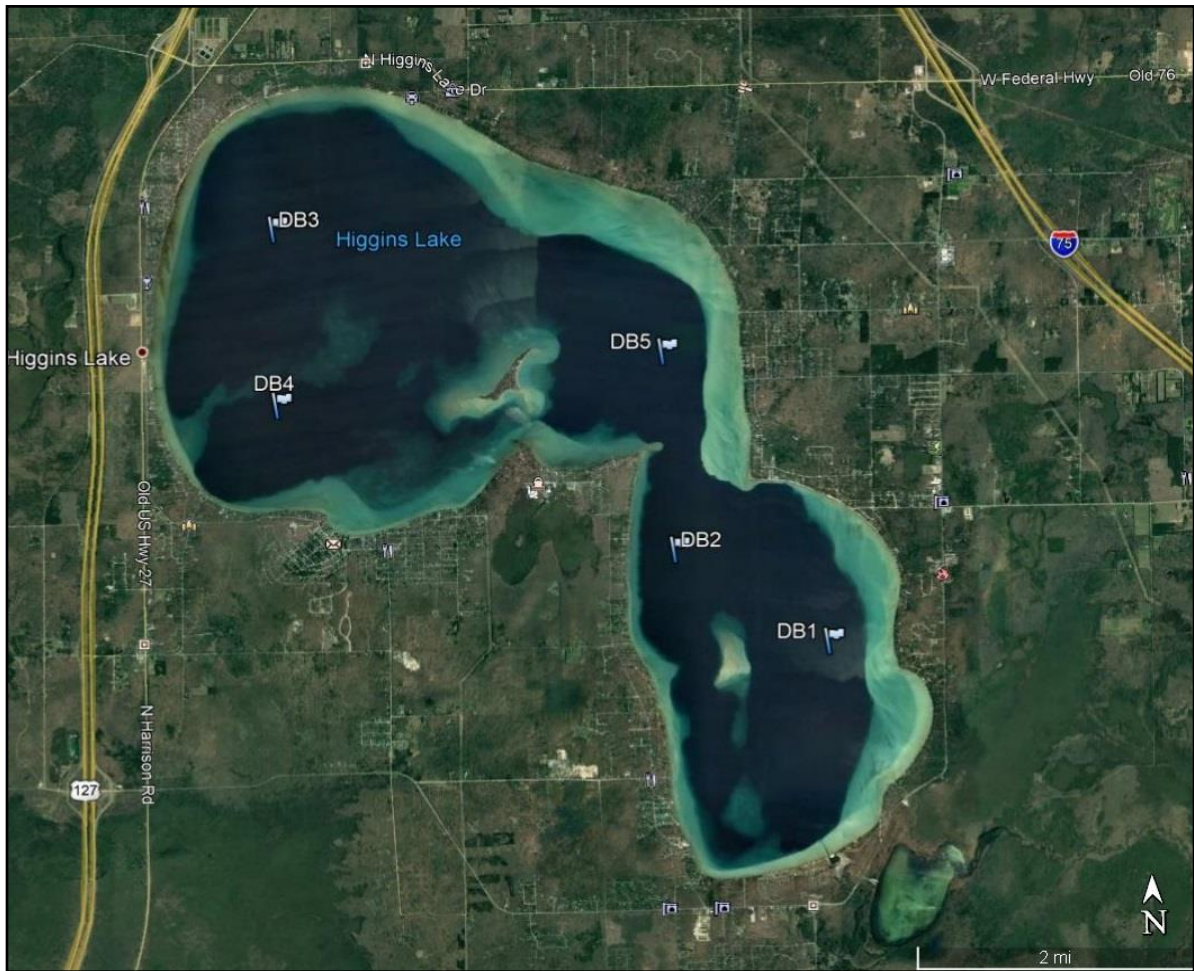
All water samples and readings were collected at the five deepest basins on August 12, 2022 with the use of a Van Dorn horizontal water sampler and calibrated Eureka Manta II® multi-meter probe with parameter electrodes, respectively. All samples were taken to a NELAC (EPA)-certified laboratory for analysis. Whenever possible, historical data comparisons were made for certain parameters that utilized similar sampling locations and methods as those used in this study.

Figure 6. Locations for deep basin water quality sampling in Higgins Lake (August 12, 2022).

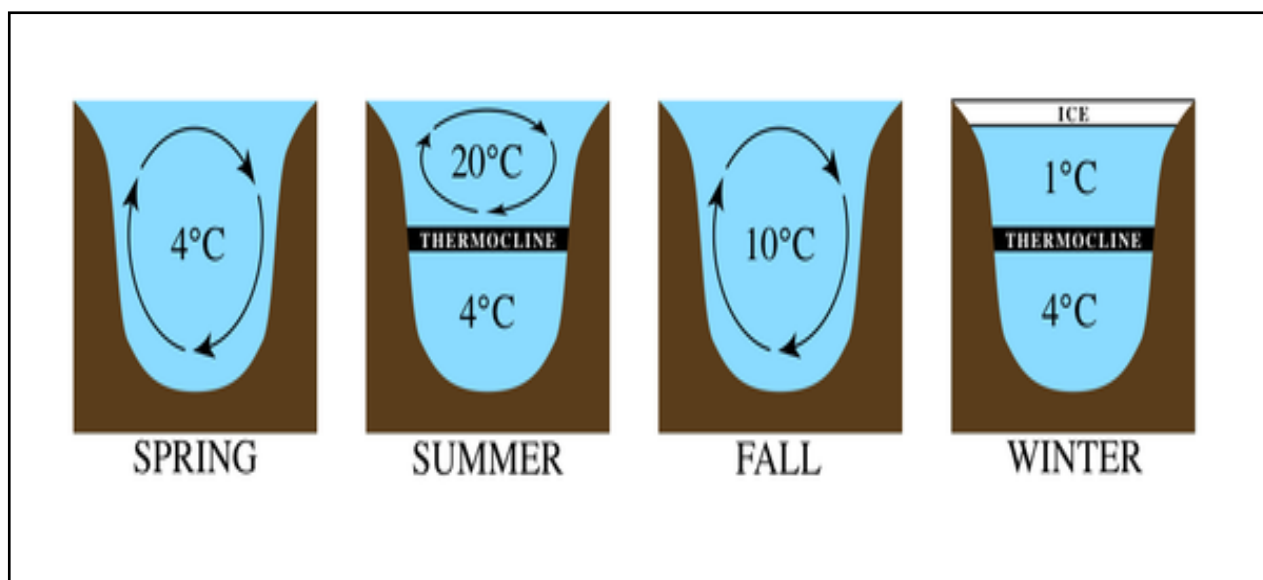
On August 12, 2022, water temperatures ranged from 23.2°C at the surface to 6.5°C at the bottom of the five deep basins. Deep basin #3 exhibited the strongest stratification with the highest water temperature difference of 16.5°C. These water temperatures are similar to those measured in 2019.

Figure 7. The lake thermal stratification process.

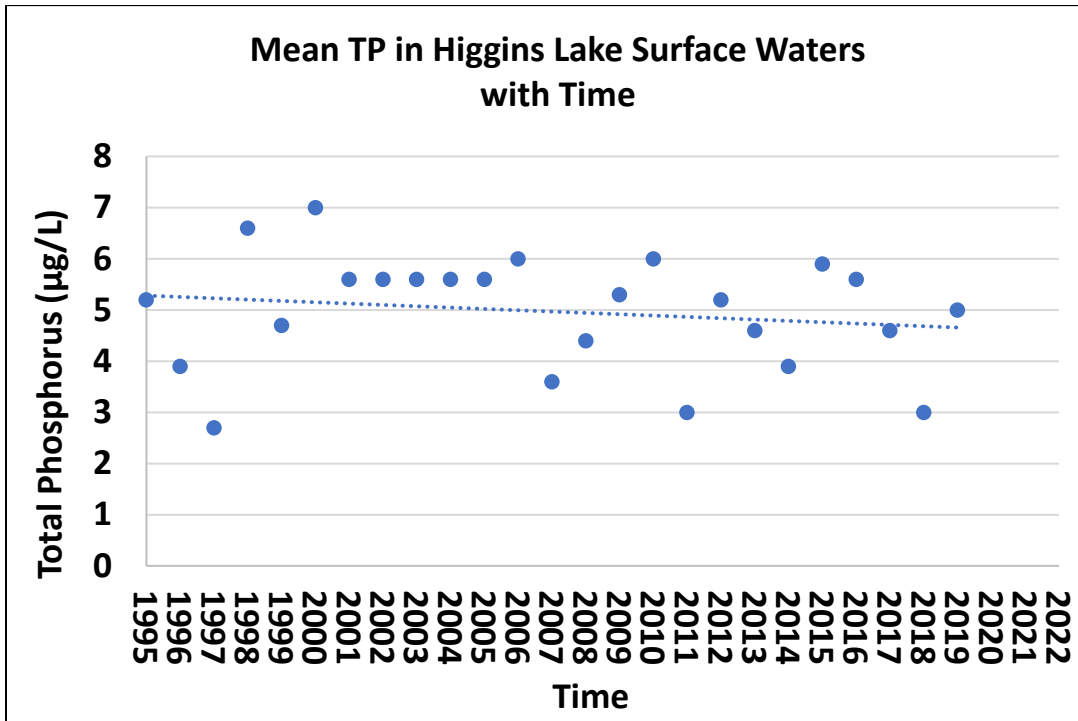
Total phosphorus (TP) is a measure of the amount of phosphorus (P) present in the water column. Phosphorus is the primary nutrient necessary for abundant algae and aquatic plant growth. Lakes which contain greater than 0.020 mg/L (or 20 µg/L) of TP are defined as eutrophic or nutrient-enriched. TP concentrations are usually higher at increased depths due to the higher release rates of P from lake sediments under low oxygen (anoxic) conditions. Phosphorus may also be released from sediments as pH increases. Total phosphorus was measured in milligrams per liter (mg/L) with the use of Method EPA 200.7 (Rev. 4.4). **The total phosphorus (TP) concentrations in the lake deep basins ranged from <0.010-0.043 mg/L during the August 22, 2019 sampling event but were all <0.010 mg/L during the August 12, 2022 sampling event.** In 2019, the highest concentration was measured near the middle of deep basin #4 and the reason for this elevated concentration is unknown. Previous studies (Minnerick, 2001) noted that phosphorus was elevated nearshore relative to the open waters which is indicative of septic system leachate entering the groundwater. An earlier USEPA study (1975) determined that the major contributing sources of phosphorus to Higgins lake in order of magnitude include direct precipitation, septic systems, minor tributaries, and Big Creek. Figure 8 demonstrates the trends in mean TP concentrations with time from the surface waters of Higgins Lake.

Figure 8. Trends in mean total phosphorus (in µg/L) with time in the surface waters of the Higgins Lake deep basins. Data from USEPA (1975), CLMP (2001-2018), and RLS (2019 and 2022). Note: comparisons for the hypolimnion could not be made due to differences in sampling methodology.

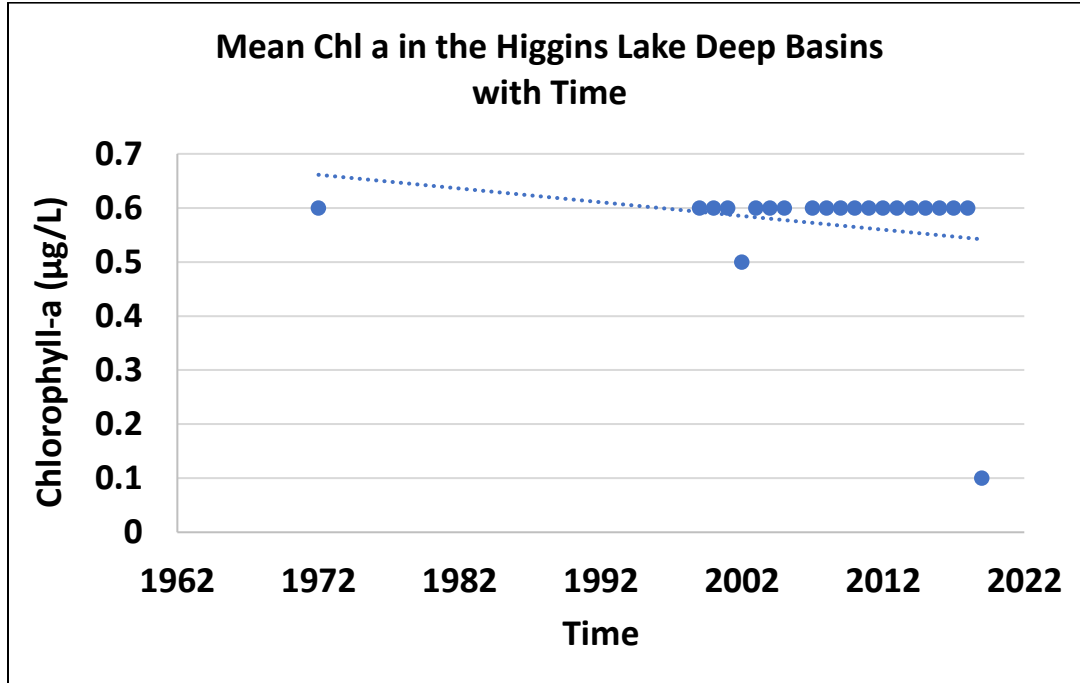
Chlorophyll-*a* is a measure of the amount of green plant pigment present in the water, often in the form of planktonic algae. High chlorophyll-*a* concentrations are indicative of nutrient-enriched lakes. Chlorophyll-*a* concentrations greater than 6 $\mu\text{g/L}$ are found in eutrophic or nutrient-enriched aquatic systems, whereas chlorophyll-*a* concentrations less than 2.2 $\mu\text{g/L}$ are found in nutrient-poor or oligotrophic lakes.

Figure 9. Trends in mean chlorophyll-*a* with time in Higgins Lake (1975-2019). Data from USEPA (1975), CLMP (2001-2018), and RLS (2019 and 2022).

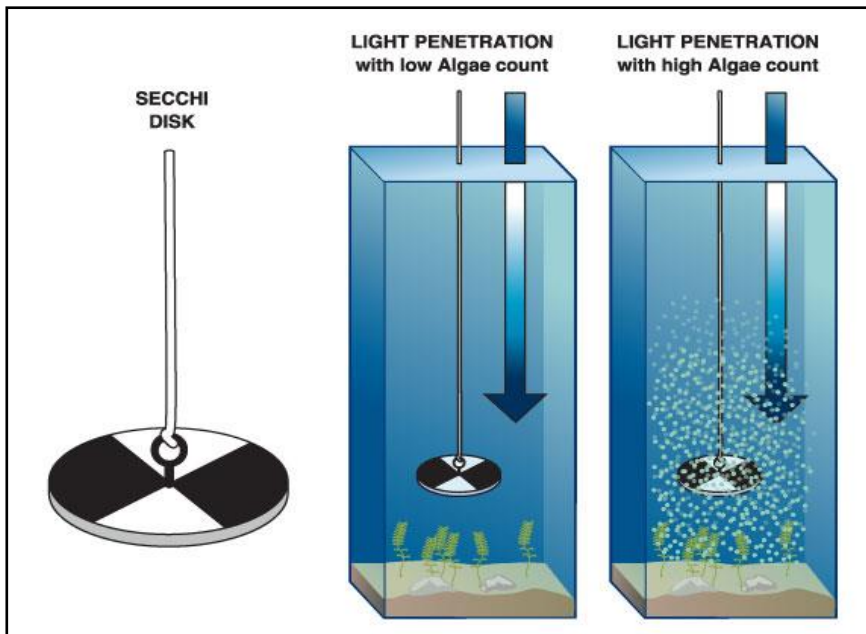
Secchi transparency is a measure of the clarity or transparency of lake water, and is measured with the use of an 8-inch diameter standardized Secchi disk. Secchi disk transparency is measured in feet (ft.) or meters (m) by lowering the disk over the shaded side of a boat around noon and taking the mean of the measurements of disappearance and reappearance of the disk (Figure 10). Elevated Secchi transparency readings allow for more aquatic plant and algae growth. Eutrophic systems generally have Secchi disk transparency measurements less than 7.5 feet due to turbidity caused by excessive planktonic algae growth. **The Secchi transparency of Higgins Lake was measured on August 12, 2022 and ranged from 31.1-35.2 feet over the deep basins which are favorable measurements. Measurements were collected during calm conditions.** This transparency indicates a low quantity of suspended particles and algae throughout the water column which would result in better water clarity. Secchi transparency is variable and depends on the amount of suspended particles in the water (often due to windy conditions of lake water mixing) and the amount of sunlight present at the time of measurement. **Secchi transparency has increased throughout time (Figure 11) due to the presence and abundance of both Zebra and Quagga Mussels which filter the algae out of the water for food.**

Figure 10. Measurement of water transparency with a Secchi disk.

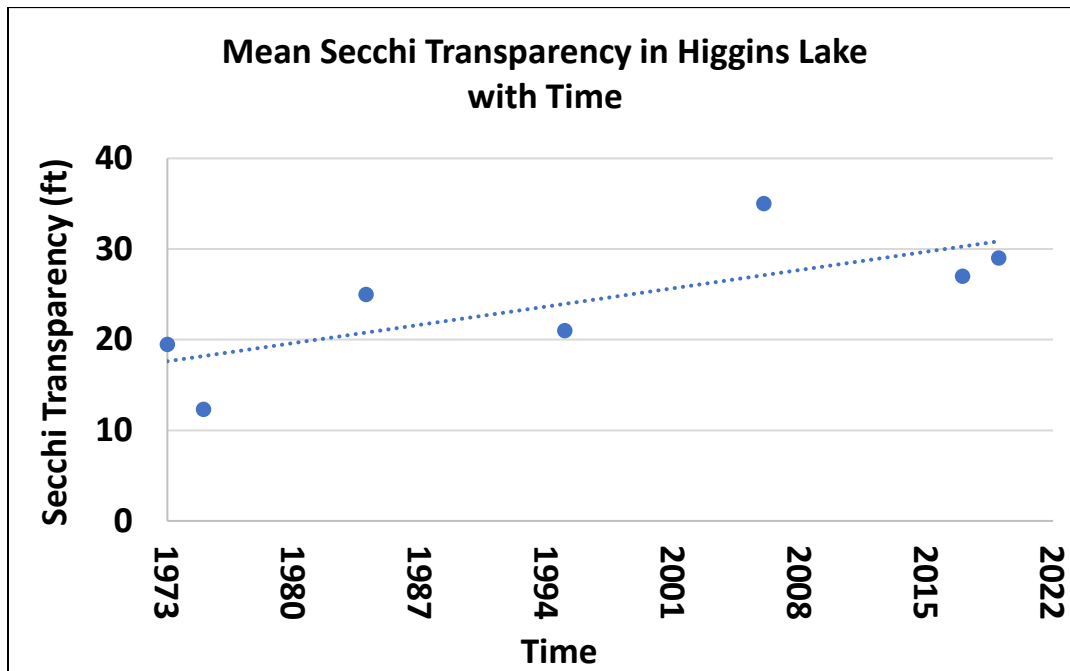
Figure 11. Trends in Secchi transparency with time in Higgins Lake (1975-2022). Data from USEPA (1975), CLMP (2001-2018), and RLS (2019 and 2022).

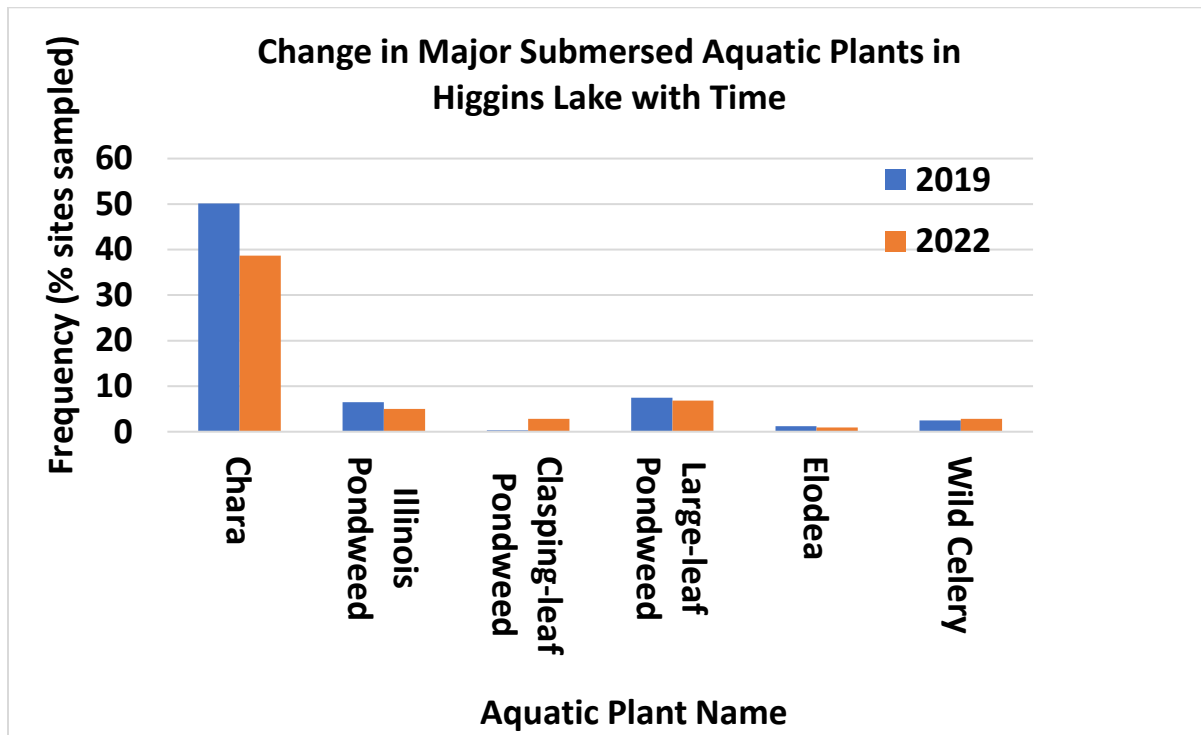
Figure 14. Change in major submersed aquatic plant taxa present in Higgins Lake 2019 and 2022.

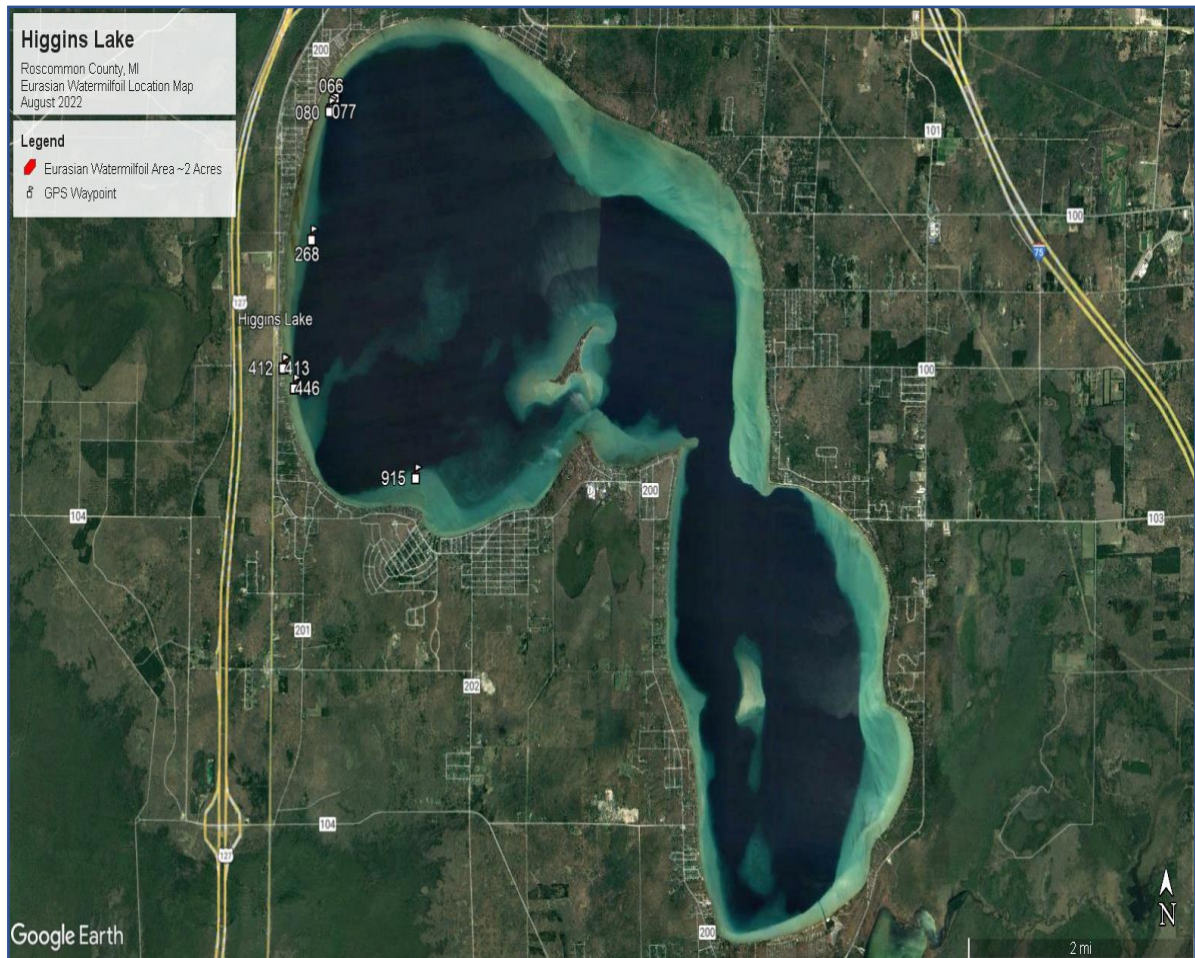
Approximately 4.0 acres of Eurasian Watermilfoil were found in Higgins Lake during the July 15-20, 2022 survey. This includes the milfoil present in the main basin as well as in the south Lagoon. Eurasian Watermilfoil growth in Higgins Lake is capable of producing dense surface canopies in shallow areas; however, many plant beds were small and covered with marl precipitate which can reduce the growth rate of the plant. The species of invasive aquatic plants present, and relative abundance of each plant are recorded and then the amount of cover in the littoral zone is calculated. Exotic aquatic plant species that have been found in Higgins Lake are shown in Table 17 below and discussions of key invasives also follow below. Additionally, some milfoil was found to have Zebra Mussels attached to the stems which allows the plants to serve as another substrate for these invasive mussels. The distribution of milfoil throughout Higgins Lake is shown below in Figure 35.

Figure 35. EWM distribution in Higgins Lake (July 15-20, and August 2-5, 2022). Note: Additional growth was reported by lake professionals later in the 2022 season which can occur at any time. This map does not show the EWM present in the south state park lagoon, where active removal was being conducted.

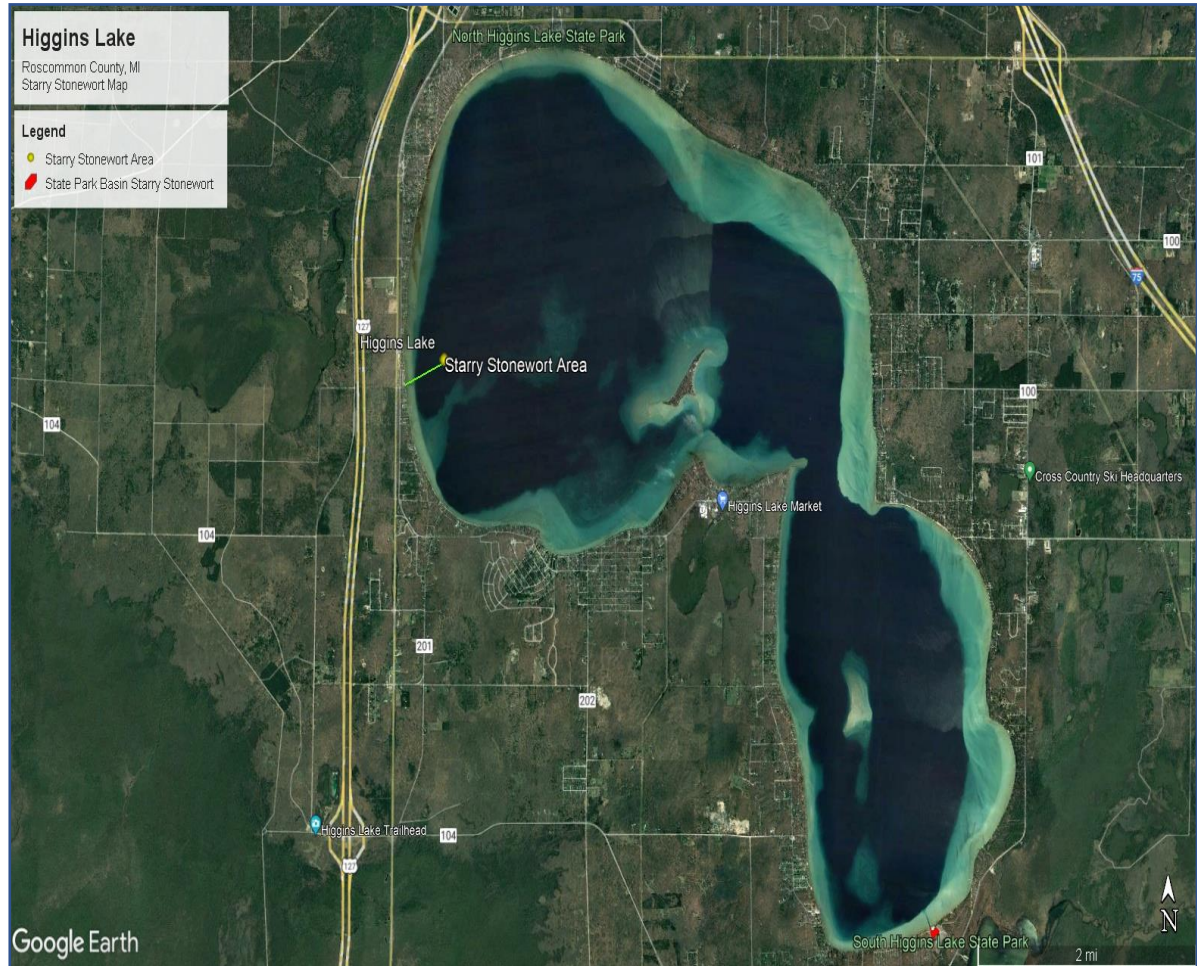
Starry Stonewort (*Nitellopsis obtusa*; Figure 36) is an invasive macro alga that has invaded many inland lakes and was originally discovered in the St. Lawrence River. The “leaves” appear as long, smooth, angular branches of differing lengths. The alga has been observed in dense beds at depths beyond several meters in clear inland lakes and can grow to heights in excess of a few meters. It prefers clear alkaline waters and has been shown to cause significant declines in water quality and fishery spawning habitat. Individual fragments can be transported to the lake via waterfowl or boats. These conditions make Higgins Lake vulnerable to its growth. It is light-limited in the deeper waters, although some free-floating fragments were found in the deeper waters. The shallows are often high-energy which may also slow down its colonization. **Approximately 2.2 acres were found throughout the lake were present in the main lake basin and in the South Park boat launch lagoon (Figure 37).**

This lagoon is currently acting as a breeding ground for the Starry Stonewort which is allowing for spread into the open waters of the lake. A rigorous management program is proposed below for this plant and Eurasian Watermilfoil.

Figure 37. Starry Stonewort distribution in the main basins of Higgins Lake (July 15-20, and August 2-5 , 2022). A total of 0.2 acres of Starry Stonewort was found in the main basin and an additional 2.0 acres combined with EWM in the South State Park Lagoon. The total of Starry Stonewort found in 2022 was 2.2 acres.

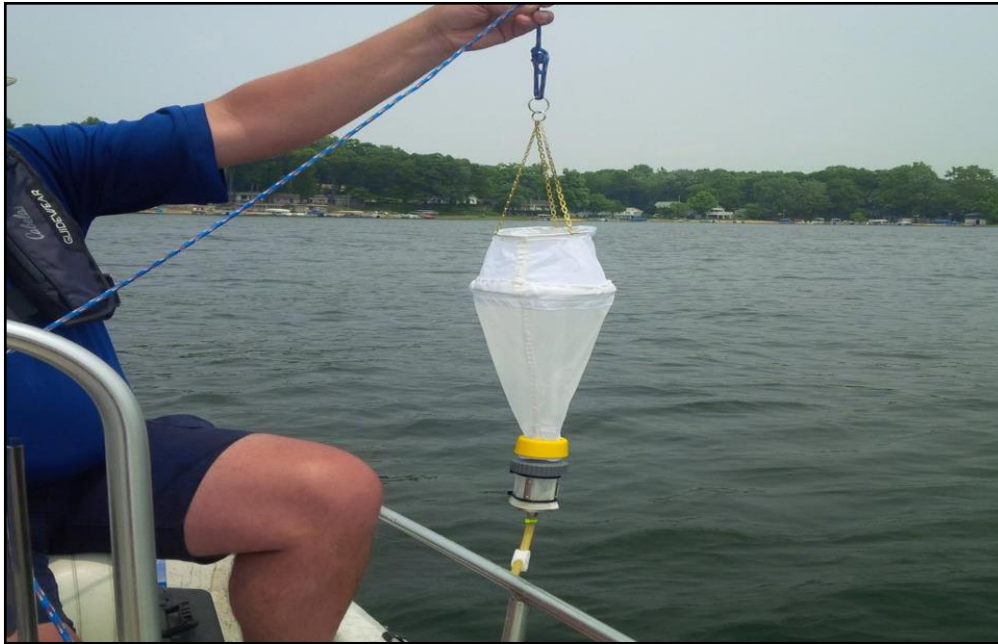
A zooplankton tow using a Wildco® pelagic plankton net (63 micrometer) with collection jar (Figure 38) was conducted by RLS scientists on August 12, 2022 over the 5 deep basins of Higgins Lake. The plankton net was left at depth for 30 seconds and then raised slowly to the surface at an approximate rate of 4 feet/second. The net was then raised above the lake surface and water was splashed on the outside of the net to dislodge any zooplankton from the net into the jar. The jar was then drained into a 125-mL bottle with a CO₂ tablet to anesthetize the zooplankton. The sample was then preserved with a 70% ethyl alcohol solution. Plankton sub-samples (in 1 ml aliquots) were analyzed under a Zeiss® dissection scope with the use of a Bogorov counting chamber. Taxa were keyed to species when possible and are shown in Tables 18-22 below.

Figure 38. A zooplankton collection tow net.

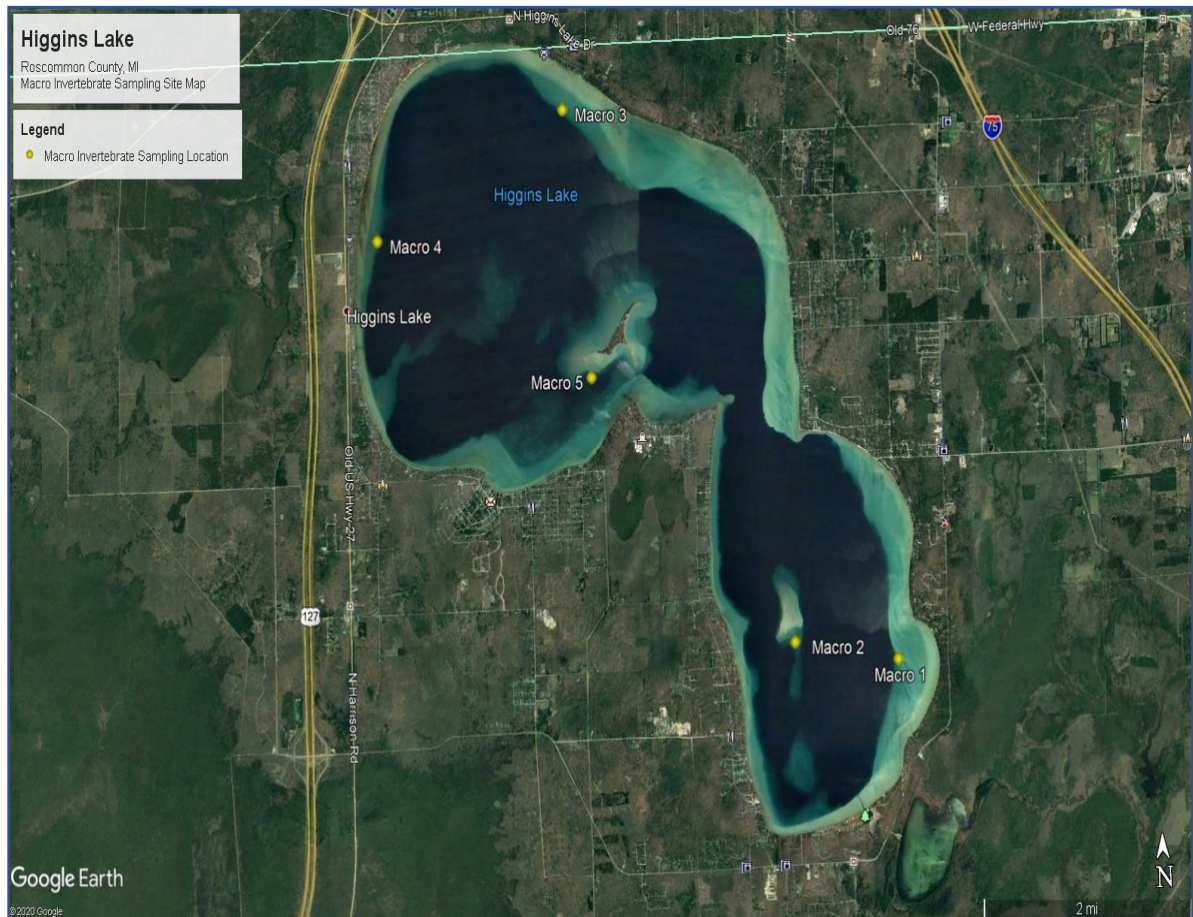
Genera found in the Higgins Lake sediment samples included midges (Chironomidae), Jute snails (Pleuroceridae), Wheel snails (Planorbidae), Right-handed snails (Lymnaeidae), Left-handed snails (Physidae), Stonefly larvae (Perlidae), and Zebra and Quagga Mussels (Dreissenidae). In 2019, the presence of Asian clams and Banded Mystery Snails was noted, but these were not present in the 2022 samples. Of all the species found, all were native except for the Zebra and Quagga Mussels, the Asian clam, and the Mystery snails. While the majority of the species were native, some are located universally in low quality and high-quality water. The midge larvae family Chironomidae can be found in both high- and low-quality water (Lenat and Barbour 1994). RLS also found native grey crayfish (*Orconectes* sp.) under a few larger rocks in the shelf littoral zone in 2022 as in 2019.

Figure 39. Sampling locations for macroinvertebrates in Higgins Lake (August 12, 2022).

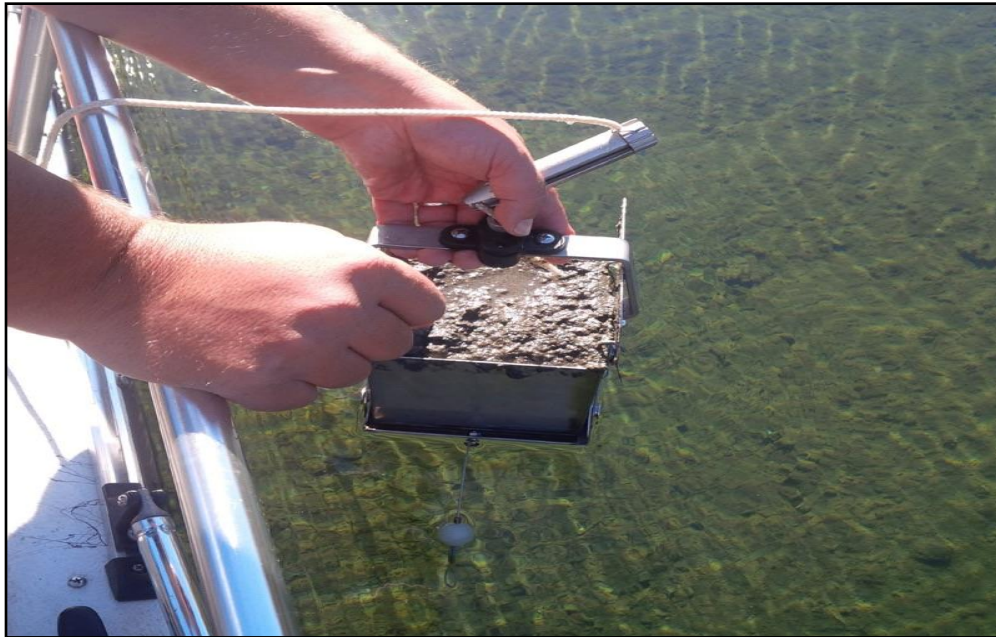
Figure 40. An Ekman hand dredge for sampling lake sediments.

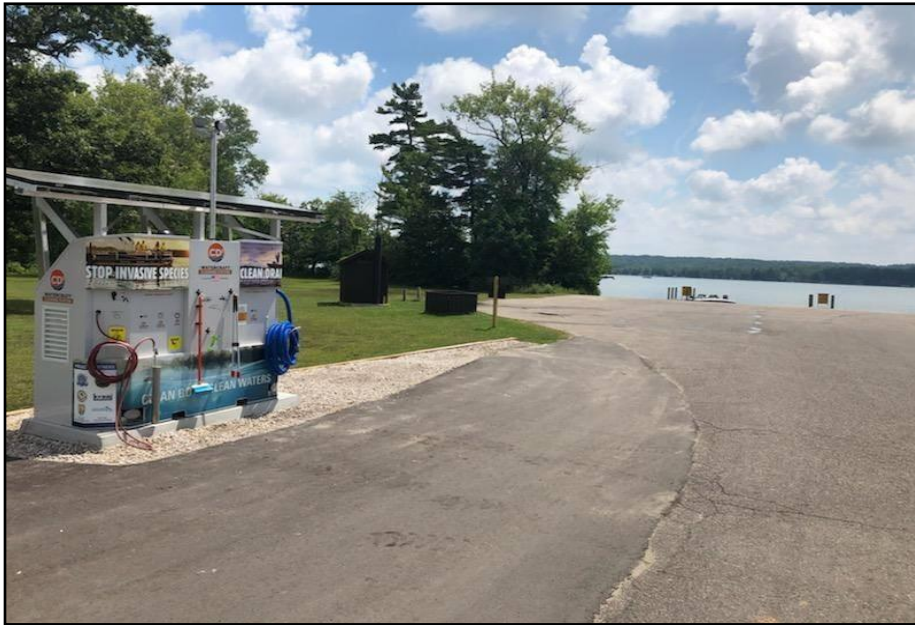
Figure 44. A public boat washing station at North Higgins Lake State Park.

RLS recommended the use of boat washing stations since they are currently installed at the north, west, and south regions of Higgins Lake. There are still other areas where they could be placed to assure access at all possible entry points.

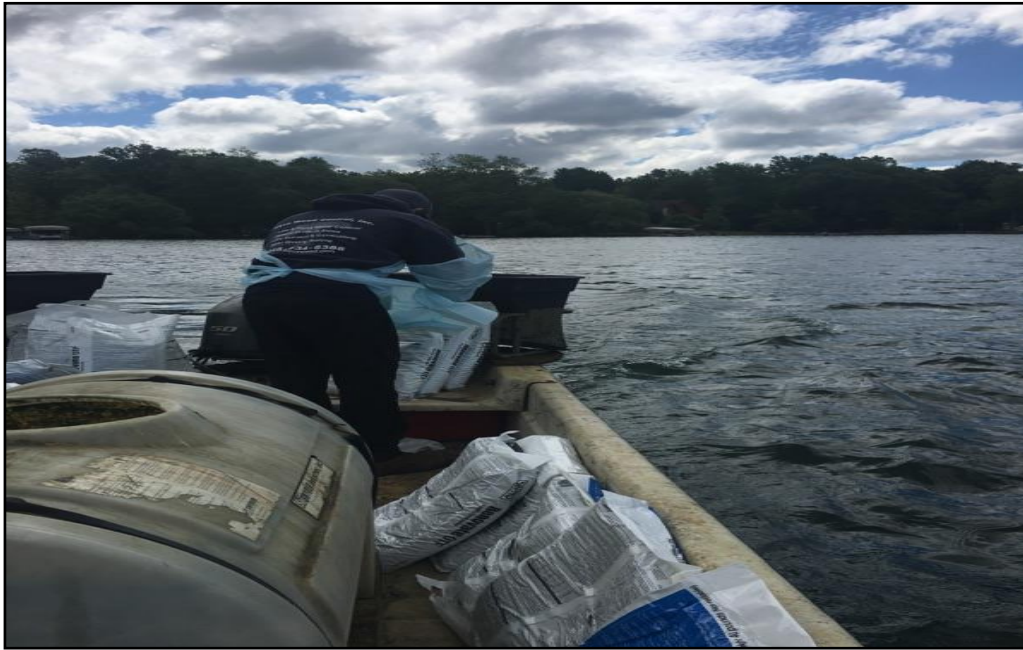
Systemic herbicides such as 2, 4-D and triclopyr are the two primary systemic herbicides used to treat milfoil that occurs in a scattered distribution. Fluridone (trade name, SONAR®) is a systemic whole-lake herbicide treatment that is applied to the entire lake volume in the spring and is used for extensive infestations. The objective of a fluridone treatment is to selectively control the growth of milfoil in order to allow other native aquatic plants to germinate and create a more diverse aquatic plant community. Due to the low scattered abundance of milfoil in Higgins Lake (given its size), the use of fluridone is not recommended. RLS recommends that no aquatic herbicides be used in Higgins Lake unless the distribution of invasives exceeds the capacity for use of a DASH boat. **If the spread of EWM exceeds the ability for DASH in the future for effective control, then a new systemic herbicide ProcellaCOR® can be used as in 2022 and is highly target-specific. The product is costly but has longer-lasting control relative to older systemic herbicides. In Higgins Lake, the dose of herbicide required to effectively treat EWM in deeper waters would be very high which would also greatly increase the cost.**

Figure 55. A boat used to apply aquatic herbicides in inland lakes.

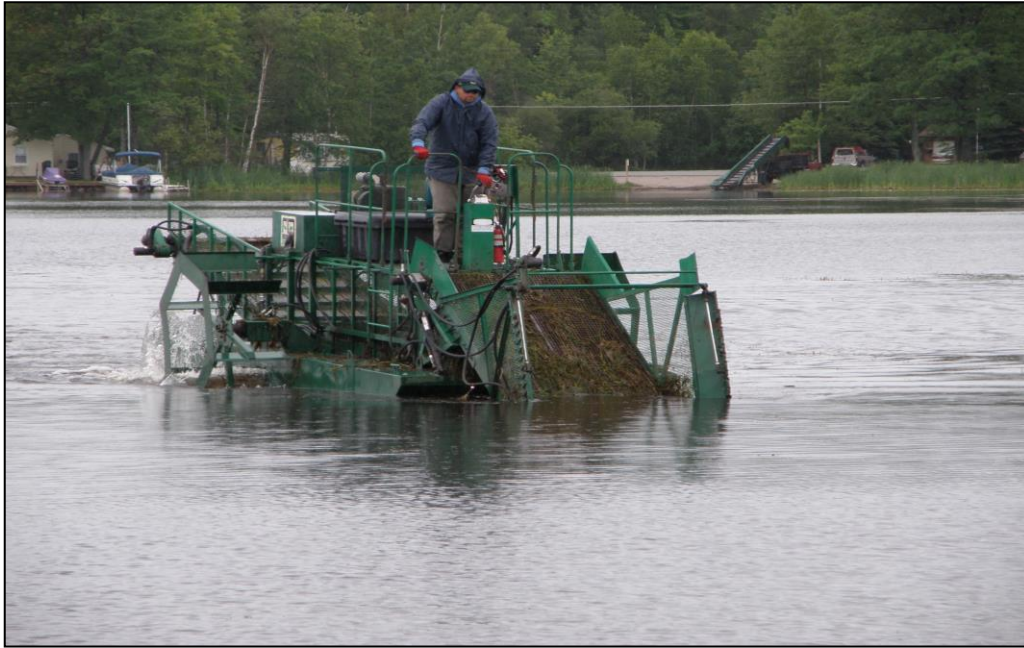
Mechanical harvesting is usually not recommended for the removal of Eurasian Watermilfoil since the plant may fragment when cut and re-grow on the lake bottom. Additionally, it is often not practical for very large lakes, given the long transfer times to offload harvested vegetation. Due to the lack of overall native aquatic vegetation and distribution of invasives in open water areas, mechanical harvesting is not recommended for Higgins Lake.

Figure 56. A mechanical harvester used to remove aquatic plants.

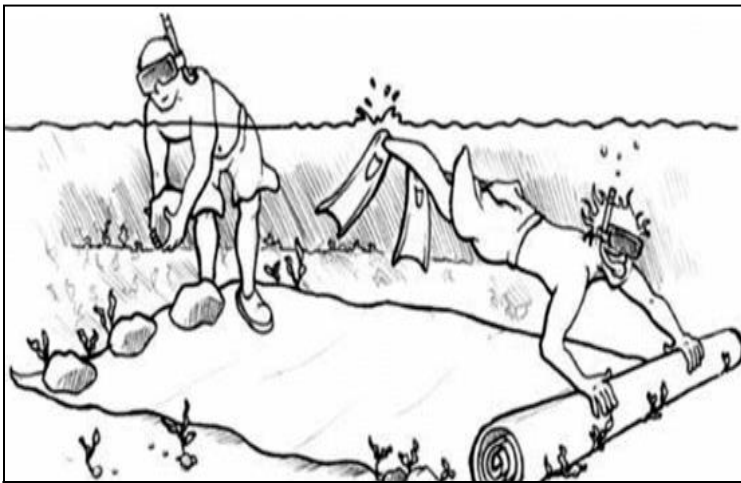
Both methods are useful in recreational lakes such as Higgins Lake and work best in beach areas and near docks to reduce nuisance aquatic vegetation growth if it becomes prevalent in future years. Fortunately, the Higgins Lake bottom is not highly colonized with aquatic vegetation and these methods are not needed in most areas.

Figure 57. A Benthic Barrier. Photo courtesy of Cornell Cooperative Extension.

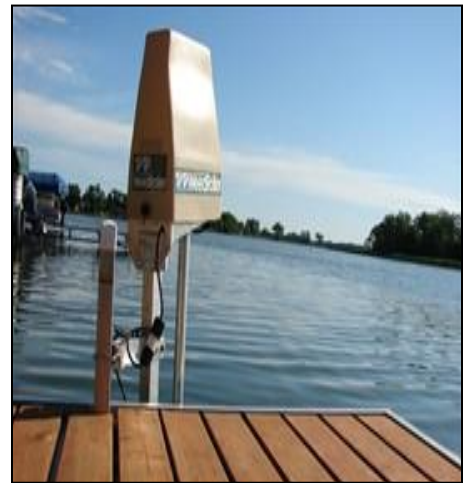
Figure 58. A Weed Roller.

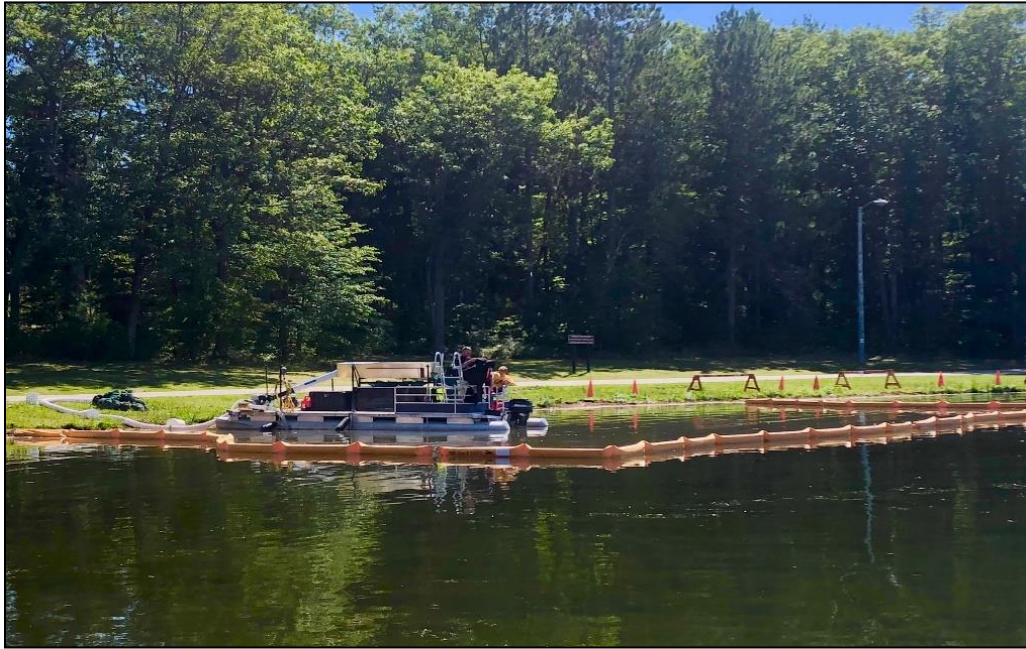
Because this activity may cause re-suspension of sediments (Nayar et al., 2007), increased turbidity and reduced clarity of the water can occur. Permitting requirements include the use of a turbidity curtain that reduce the transport of solids to locations outside of treatment areas and also help define areas where intensive aquatic vegetation removal efforts are being implemented. This method would be feasible given the sparse distribution of invasive Eurasian Watermilfoil and Starry Stonewort scattered throughout Higgins Lake. It would be a non-chemical approach that would include removal of the roots for long-term, sustainable, control of invasive plants.

Figure 59. A DASH boat used in the South State Park Lagoon for aquatic plant removal.

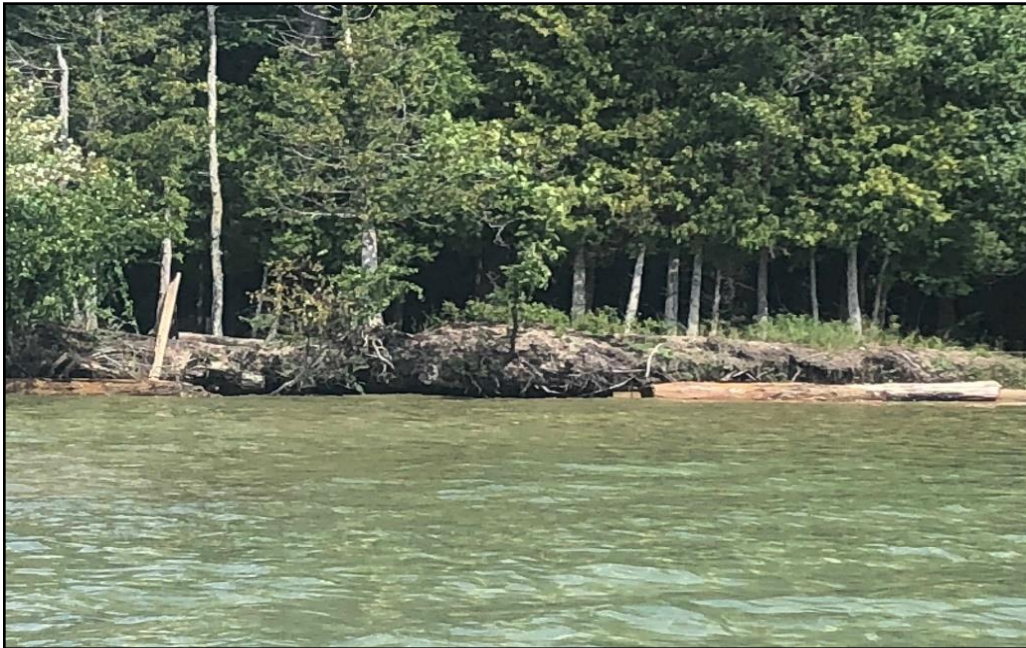
Additional steps needed would include a detailed assessment in order to prioritize sites based on severity, feasibility, costs, landowner willingness, and other factors. There is a wide range of erosion control methods that can be used in a cost-effective manner to address the shoreline erosion problems. Higher priority should go to sites where structures or amenities are threatened. Figures 60-62 demonstrate areas around the lake with different types of erosion including hill erosion, bank erosion, bank undercutting, and low stabilization.

Figure 60. Shoreline erosion on Higgin Lake with bank undercutting (August 21-23, 2019).

A few areas around the lake (aside from road ends) were found to have shoreline erosion during the 2019 evaluation and these areas should be stabilized with rip-rap or soft shoreline emergent vegetation as soon as possible.

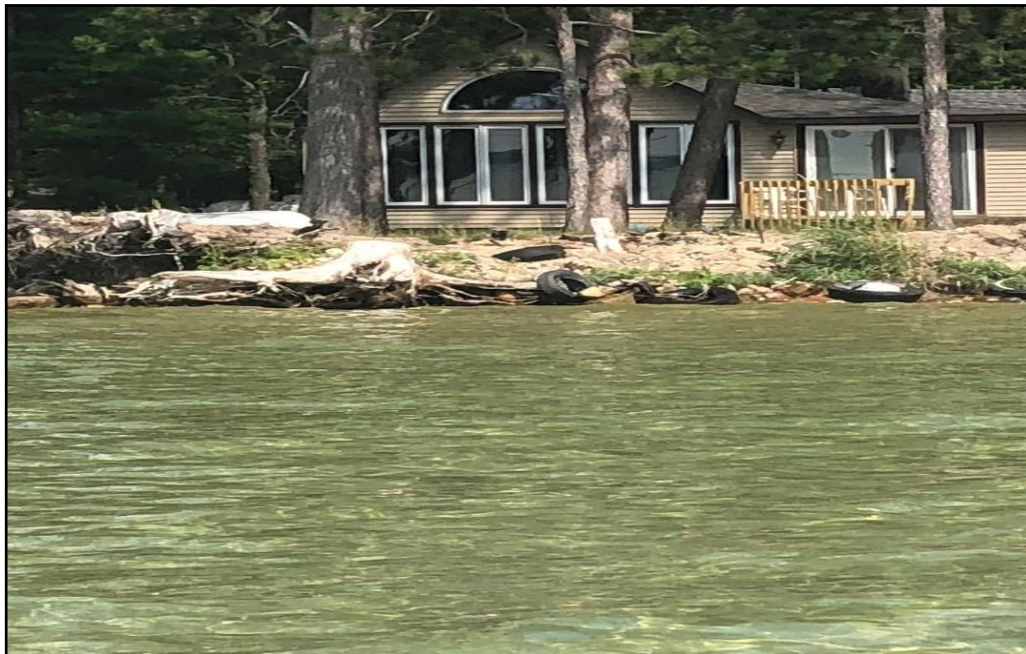
Figure 61. Higgins Lake shoreline erosion (August 21-23, 2019).

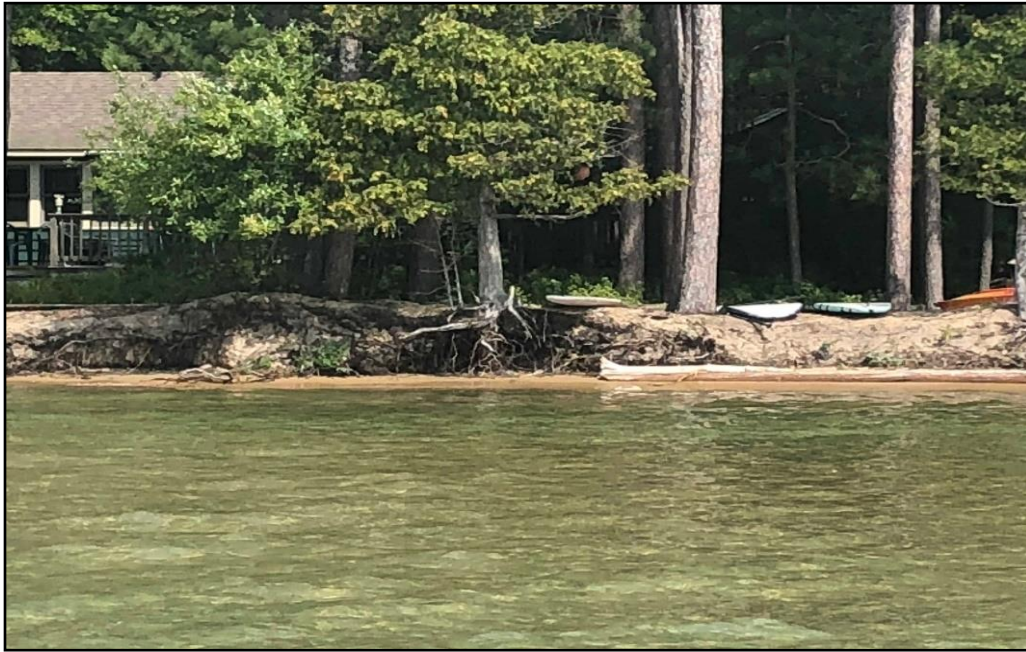
Figure 62. Higgins Lake shoreline erosion exposing tree roots (August 21-23, 2019).
